Access Compliance Report

Public Rights-of-Way

(Curb Ramps)

Intersection ID: 24562	Main Street: CAVAN_CT	Cross Street: SWINFORD_PL	Location: NE
ADA ID: 81A1594ADDD9	Ramp Type: Perp	Initial Pass/Fail: Fail	Overall Compliance: No
Severity Score: 33.75			
Codes/Mitigation Info/Possible Solution		Field Measurements/Component Compliance

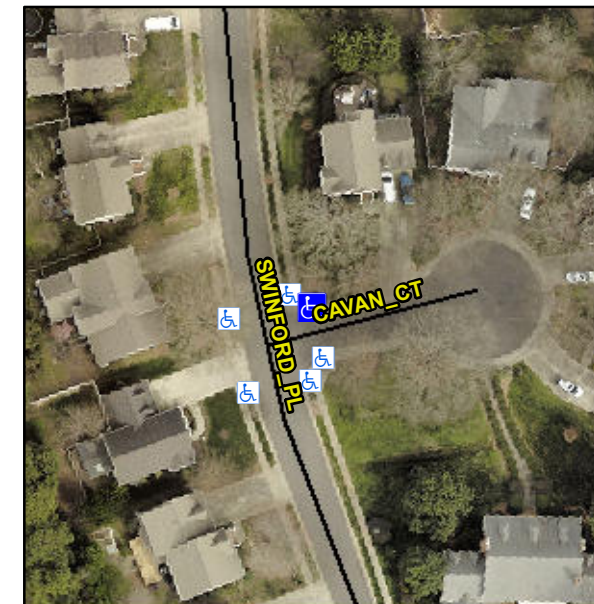
Compliance	Description	Data	Compliance	Description	Data
N/A	Ramp Length (in)	48.0	Yes	Ramp Slope (%)	6.2
No	Ramp Width (in)	41.5	No	Ramp XSlope (%)	7.2
N/A	Flare Type LT	N/A	N/A	Flare Type RT	N/A
N/A	Flare Slope LT (%)	N/A	N/A	Flare Slope RT (%)	N/A
N/A	Flare Traversable LT?	N/A	N/A	Flare Traversable RT?	N/A
N/A	Landing Length (in)	N/A	N/A	DWS Provided?	N/A
N/A	Landing Width (in)	N/A	N/A	DWS Contrast?	N/A
N/A	Landing Slope (%)	N/A	N/A	DWS Length (in)	N/A
N/A	Landing X Slope (%)	N/A	N/A	DWS Full Width?	N/A
N/A	Landing Curb? (Y/N)	N/A	N/A	DWS Offset (in)	N/A
N/A	Shared Landing?	N/A			
N/A	Gutter Ponding?	N/A	N/A	Gutter Slope (%)	N/A
N/A	Gutter Lip Ht (in)	N/A	N/A	Gutter X Slope (%)	N/A
N/A	Painted X Walk1?	No	N/A	Painted X Walk2?	N/A
	X Walk 1 Direction	To S		X Walk 2 Direction	N/A
N/A	X Walk 1 Width (in)	N/A	N/A	X Walk 2 Width (in)	N/A
	X Walk 1 Slope (%)	2.2		X Walk 2 Slope (%)	N/A
	X Walk 1 X Slope (%)	3.5		X Walk 2 X Slope (%)	N/A

N/A	Ramp inside XWalk1?	N/A	N/A	Ramp inside XWalk2?	N/A
	Road Slope (%)	N/A	N/A	Clear Space?	N/A
	Road X Slope (%)	N/A	N/A	Clear Space to XWalk (in)	N/A
N/A	Any Obstructions?	N/A	N/A	Storm Grate/Utility Hazard?	N/A
	Obstruction Type			Storm Grate/Utility Type	
		N/A			N/A
			Yes	Surface Condition? (G/P)	Good

Possible Solutions:

Remove & Replace Entire Ramp.

R304.5.1, R304.5.3
