# Access Compliance Report

## Public Rights-of-Way

### (Curb Ramps)

| Intersection ID: 46820 | Main Street: NORWAY_SPRUCE_CT | Cross Street: AZALEA_HILLS_DR | Location: E |

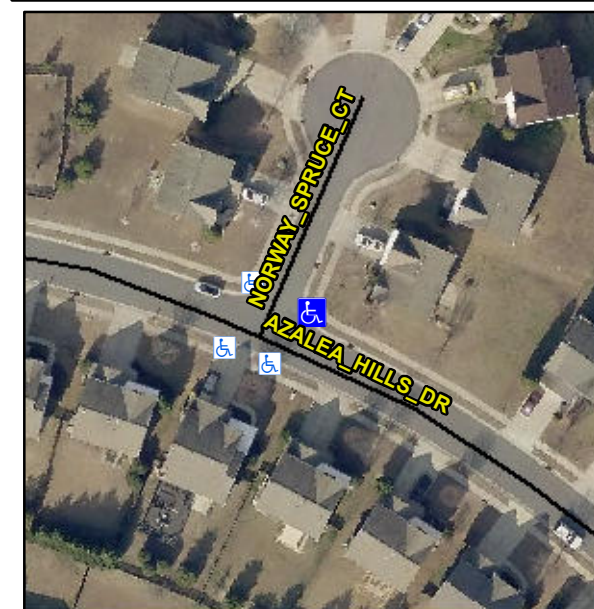
**R304.5.1, R304.2.2**

| Compliance | Description | Data | Compliance | Description | Data |
|---|---|---|---|---|---|
| N/A | Ramp Length (in) | 47.0 | No | Ramp Slope (%) | 10.7 |
| No | Ramp Width (in) | 46.5 | Yes | Ramp XSlope (%) | 0.2 |

**Remove & Replace Curb Ramp With Two New Directional Ramps or Equivalent.**

Total Cost: \$ 3200.00
