Access Compliance Report Public Rights-of-Way (Curb Ramps)

Intersection ID: N/A Main Street: SHARON_VIEW_RD Cross Street: LOUISBURG_SQUARE_LN Location: NW
ADA ID: 81A75111357C Ramp Type: Perp Initial Pass/Fail: Fail Overall Compliance: No Severity Score: 1.25

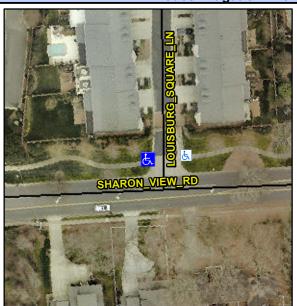
Pielu Measurements/Component Compilance						
	oliance Description	Data		oliance Description	Data	
N/A	Ramp Length (in)	54.0	Yes	Ramp Slope (%)	5.8	
Yes	Ramp Width (in)	60.0	No	Ramp XSlope (%)	2.4	
N/A	Flare Type LT	N/A	N/A	Flare Type RT	N/A	
N/A	Flare Slope LT (%)	N/A	N/A	Flare Slope RT (%)	N/A	
N/A	Flare Traversable LT?	N/A	N/A	Flare Traversable RT?	N/A	
N/A	Landing Length (in)	N/A	N/A	DWS Provided?	N/A	
N/A	Landing Width (in)	N/A	N/A	DWS Contrast?	N/A	
N/A	Landing Slope (%)	N/A	N/A	DWS Length (in)	N/A	
N/A	Landing X Slope (%)	N/A	N/A	DWS Full Width?	N/A	
N/A	Landing Curb? (Y/N)	N/A	N/A	DWS Offset (in)	N/A	
N/A	Shared Landing?	N/A				
N/A	Gutter Ponding?	N/A	N/A	Gutter Slope (%)	N/A	
N/A	Gutter Lip Ht (in)	N/A	N/A	Gutter X Slope (%)	N/A	
N/A	Painted X Walk1?	No	N/A	Painted X Walk2?	N/A	
	X Walk 1 Direction	To E		X Walk 2 Direction	N/A	
N/A	X Walk 1 Width (in)	N/A	N/A	X Walk 2 Width (in)	N/A	
	X Walk 1 Slope (%)	0.8		X Walk 2 Slope (%)	N/A

X Walk 1 X Slope (%)	1.2		X Walk 2 X Slope (%)	N/A	
N/A	Ramp inside XWalk1?	N/A	N/A	Ramp inside XWalk2?	N/A	
	Road Slope (%)	N/A	N/A	Clear Space?	N/A	
	Road X Slope (%)	N/A	N/A	Clear Space to XWalk (in)	N/A	
N/A	Any Obstructions?	N/A	N/A	Storm Grate/Utility Hazard?	N/A	
	Obstruction Type			Storm Grate/Utility Type		
		N/A			N/A	
			Yes	Surface Condition? (G/P)	Good	
		,	-	` ,

/Possible Solution	
Possible Solutions:	
Remove & Replace Entire Ramp.	
Surveyor Notes:	
N/A	
PROW/ADA:	
R304.5.3	
R304.5.3
