# Access Compliance Report

## Public Rights-of-Way

### (Curb Ramps)

| Intersection ID: 12728 | Main Street: E_10TH_ST | Cross Street: SEIGLE_AV | Location: N |

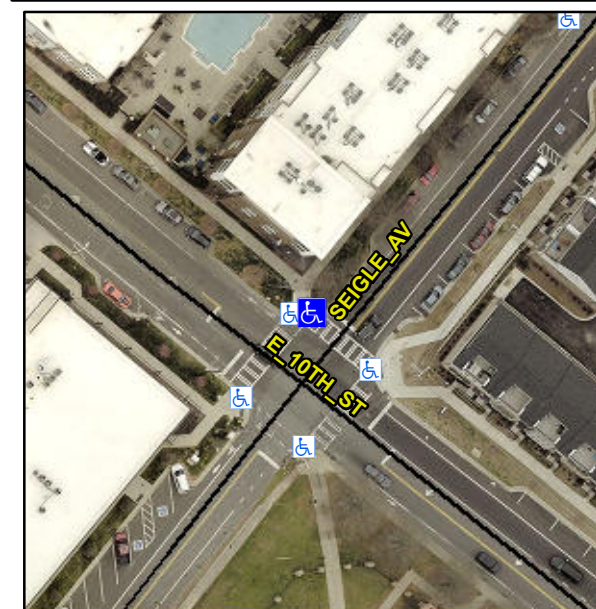
**Not Found, R304.5.3, R305.2, R302.7.2**

| Compliance | Description | Data | Compliance | Description | Data |
|---|---|---|---|---|---|
| Yes | Ramp Width (in) | 70.5 | No | BlendTrans XSlope (%) | 3.6 |
| N/A | Landing Curb? (Y/N) | No | No | DWS Offset (in) | 7.0 |
| No | Gutter Lip Ht (in) | 0.3 | No | Gutter X Slope (%) | 4.2 |
| | | | No | Curb Slope (%) | 10.3 |

**Remove & Replace Curb Ramp With Two New Directional Ramps or Equivalent. Remove & Replace Gutter.**
