Intersection ID: 47983	Main Street: SPRINGS_MILL_RD	Cross Street: WHEAT_RIDGE_RD	Location:	NE
ADA ID: 81BA00A5BDCC	Ramp Type: PerpDiag	Initial Pass/Fail: Pass	Overall Compliance: No	Severity Score: 5.25

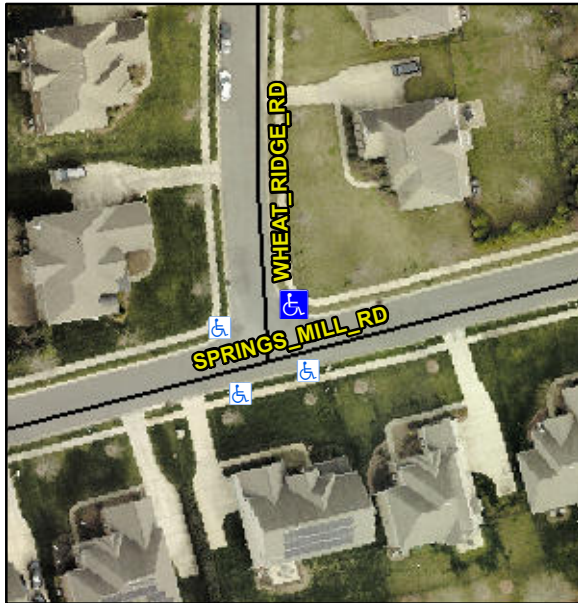
**Not Found, R304.5.3, R304.2.2-Perp,  
R304.3.2-Para, R305.2, R304.5.4**

Compliance	Description	Data	Compliance	Description	Data
N/A	Ramp Length (in)	51.0	Yes	Ramp Slope (%)	5.6
Yes	Ramp Width (in)	48.0	No	Ramp XSlope (%)	4.0
N/A	Flare Type LT	Sloped	N/A	Flare Type RT	N/A
N/A	Flare Slope LT (%)	1.3	N/A	Flare Slope RT (%)	7.0
N/A	Flare Traversable LT?	No	N/A	Flare Traversable RT?	No
Yes	Landing Length (in)	48.5	Yes	DWS Provided?	Yes
Yes	Landing Width (in)	48.0	Yes	DWS Contrast?	Yes
No	Landing Slope (%)	3.1	Yes	DWS Length (in)	24.0
Yes	Landing X Slope (%)	1.6	Yes	DWS Full Width?	Yes
N/A	Landing Curb? (Y/N)	No	No	DWS Offset (in)	5.0
N/A	Shared Landing?	No			
Yes	Gutter Ponding?	No	No	Gutter Slope (%)	5.9
Yes	Gutter Lip Ht (in)	0.0	Yes	Gutter X Slope (%)	1.0
N/A	Painted X Walk1?	No	N/A	Painted X Walk2?	No
	X Walk 1 Direction	To W		X Walk 2 Direction	To S
N/A	X Walk 1 Width (in)	N/A	N/A	X Walk 2 Width (in)	N/A
	X Walk 1 Slope (%)	0.2		X Walk 2 Slope (%)	1.8
	X Walk 1 X Slope (%)	1.3		X Walk 2 X Slope (%)	1.8

N/A	Ramp inside XWalk1?	N/A	N/A	Ramp inside XWalk2?	N/A
	Road Slope (%)	1.4	N/A	Clear Space?	Yes
	Road X Slope (%)	0.9	N/A	Clear Space to XWalk (in)	N/A
Yes	Any Obstructions?	No	Yes	Storm Grate/Utility Hazard?	No
	Obstruction Type			Storm Grate/Utility Type	
		N/A			N/A
			Yes	Surface Condition? (G/P)	Good

**Remove & Replace Curb Ramp With Two New Directional Ramps or Equivalent. Remove & Replace Gutter.**

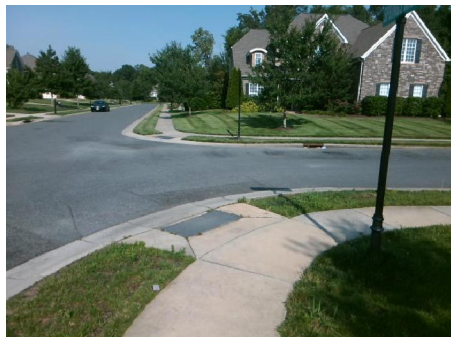
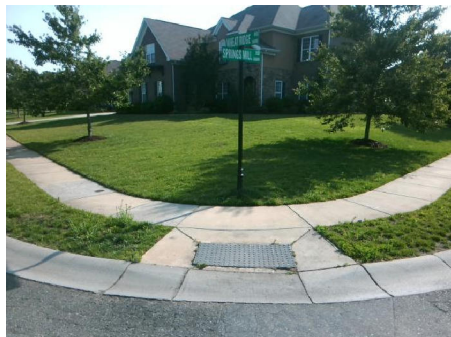
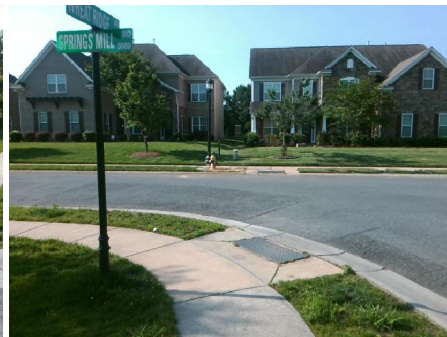
Street 1 Name	WHEAT RIDGE RD
Stop Condition-Street 2	StopSign
Street 2 Name	SPRINGS MILL RD
Stop Condition-Street 1	None
