Access Compliance Report

Public Rights-of-Way

(Curb Ramps)

Intersection ID: 10005	Main Street: ROSLYN_AV	Cross Street: S_GARDNER_AV	Location:	N
ADA ID: 81C2E013D45B	Ramp Type: BlendTrans2	Initial Pass/Fail: Fail	Overall Compliance: No	Severity Score: 10
Codes/Mitigation Info/Possible Solution		Field Measurements/Component Compliance

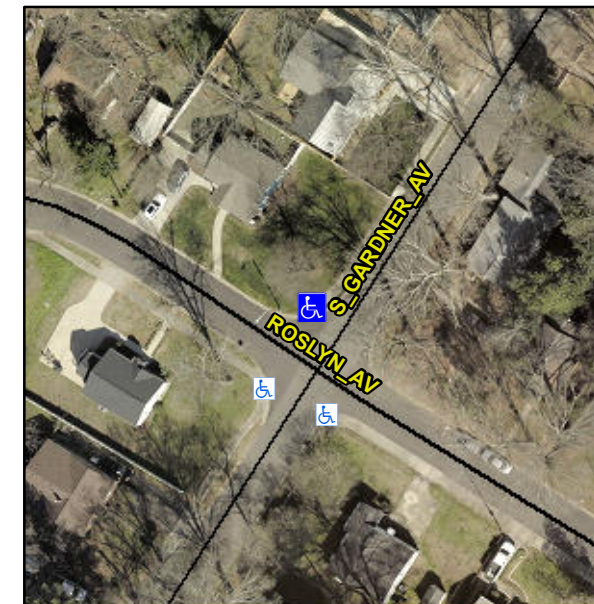
NO RT SW

Not Found, R304.5.1, R304.5.3

Compliance	Description	Data	Compliance	Description	Data
N/A	Ramp Length (in)	84.0	Yes	BlendTrans Slope (%)	2.4
No	Ramp Width (in)	46.0	No	BlendTrans XSlope (%)	4.4
N/A	Flare Type LT	N/A	N/A	Flare Type RT	N/A
N/A	Flare Slope LT (%)	N/A	N/A	Flare Slope RT (%)	N/A
N/A	Flare Traversable LT?	N/A	N/A	Flare Traversable RT?	N/A
N/A	Landing Length (in)	N/A	N/A	DWS Provided?	N/A
N/A	Landing Width (in)	N/A	N/A	DWS Contrast?	N/A
N/A	Landing Slope (%)	N/A	N/A	DWS Length (in)	N/A
N/A	Landing X Slope (%)	N/A	N/A	DWS Full Width?	N/A
N/A	Landing Curb? (Y/N)	N/A	N/A	DWS Offset (in)	N/A
N/A	Shared Landing?	N/A			
N/A	Gutter Ponding?	N/A	N/A	Gutter Slope (%)	N/A
N/A	Gutter Lip Ht (in)	0.5	N/A	Gutter X Slope (%)	N/A
N/A	Painted X Walk1?	No	N/A	Painted X Walk2?	N/A
	X Walk 1 Direction	To SW		X Walk 2 Direction	N/A
	X Walk 1 Width (in)	N/A		X Walk 2 Width (in)	N/A
	X Walk 1 Slope (%)	0.5		X Walk 2 Slope (%)	N/A
	X Walk 1 X Slope (%)	3.5		X Walk 2 X Slope (%)	N/A

N/A	Ramp inside XWalk1?	N/A	N/A	Ramp inside XWalk2?	N/A
	Road Slope (%)	3.5		Clear Space?	N/A
	Road X Slope (%)	0.5	N/A	Clear Space to XWalk (in)	N/A
N/A	Any Obstructions?	N/A	N/A	Storm Grate/Utility Hazard?	N/A
	Obstruction Type			Storm Grate/Utility Type	
		N/A			N/A
			Yes	Surface Condition? (G/P)	Good
			No	Curb Slope (%)	15.5

Possible Solutions:

Remove & Replace Curb Ramp With Two New Directional Ramps or Equivalent.
