Access Compliance Report

Public Rights-of-Way

(Curb Ramps)

Intersection ID: 18813	Main Street: BUCKINGHAM_DR	Cross Street: SENECA_PL	Location: SE
ADA ID: 81C79787DEA0	Ramp Type: PerpDiag	Initial Pass/Fail: Fail	Overall Compliance: No
Severity Score: 13.75			
Codes/Mitigation Info/Possible Solution		Field Measurements/Component Compliance

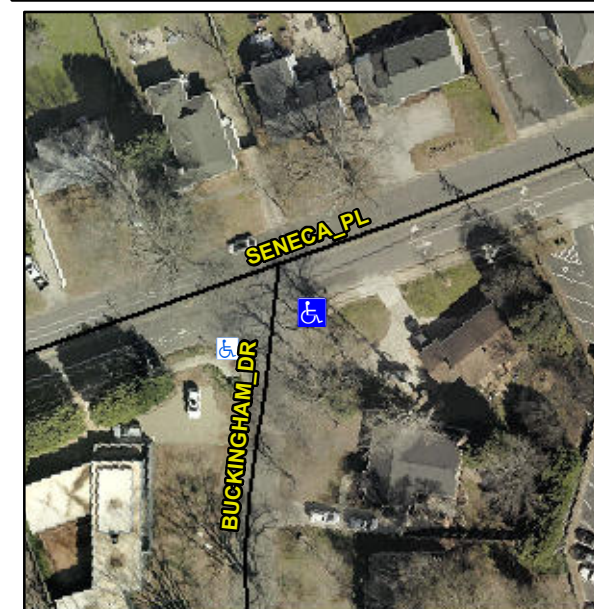
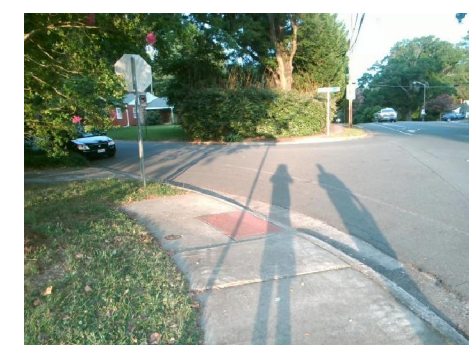
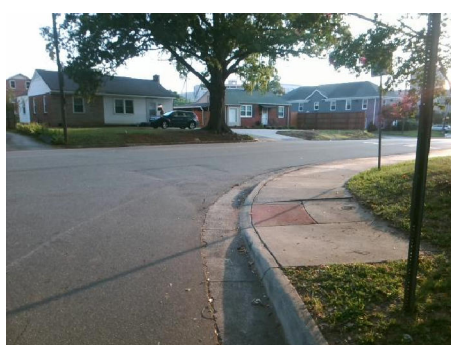
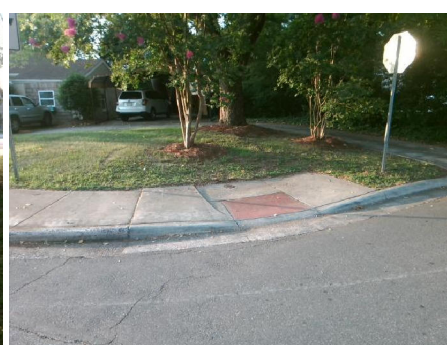
Not Found, R304.2.2, R304.5.3

Compliance	Description	Data	Compliance	Description	Data
N/A	Ramp Length (in)	74.5	No	Ramp Slope (%)	8.6
Yes	Ramp Width (in)	55.5	No	Ramp XSlope (%)	2.5
N/A	Flare Type LT	N/A	N/A	Flare Type RT	N/A
N/A	Flare Slope LT (%)	N/A	N/A	Flare Slope RT (%)	N/A
N/A	Flare Traversable LT?	N/A	N/A	Flare Traversable RT?	N/A
N/A	Landing Length (in)	N/A	N/A	DWS Provided?	N/A
N/A	Landing Width (in)	N/A	N/A	DWS Contrast?	N/A
N/A	Landing Slope (%)	N/A	N/A	DWS Length (in)	N/A
N/A	Landing X Slope (%)	N/A	N/A	DWS Full Width?	N/A
N/A	Landing Curb? (Y/N)	N/A	N/A	DWS Offset (in)	N/A
N/A	Shared Landing?	N/A			
N/A	Gutter Ponding?	N/A	N/A	Gutter Slope (%)	N/A
N/A	Gutter Lip Ht (in)	N/A	N/A	Gutter X Slope (%)	N/A
N/A	Painted X Walk1?	No	N/A	Painted X Walk2?	No
	X Walk 1 Direction	To N		X Walk 2 Direction	To W
N/A	X Walk 1 Width (in)	N/A	N/A	X Walk 2 Width (in)	N/A
	X Walk 1 Slope (%)	4.8		X Walk 2 Slope (%)	3.5
	X Walk 1 X Slope (%)	3.8		X Walk 2 X Slope (%)	3.4

N/A	Ramp inside XWalk1?	N/A	N/A	Ramp inside XWalk2?	N/A
	Road Slope (%)	1.0	N/A	Clear Space?	N/A
	Road X Slope (%)	6.0	N/A	Clear Space to XWalk (in)	N/A
N/A	Any Obstructions?	N/A	N/A	Storm Grate/Utility Hazard?	N/A
	Obstruction Type			Storm Grate/Utility Type	
		N/A			N/A
			Yes	Surface Condition? (G/P)	Good

Remove & Replace Curb Ramp With Two New Directional Ramps or Equivalent.

Total Cost: \$ 3200.00
