## Access Compliance Report Public Rights-of-Way (Curb Ramps)

Intersection ID: 50619Main Street: COTTON\_GUM\_RDCross Street: YELLOW\_OAK\_RDLocation:NWADA ID: 81C799340944Ramp Type: PerpInitial Pass/Fail: FailOverall Compliance: NoSeverity Score: 8.75

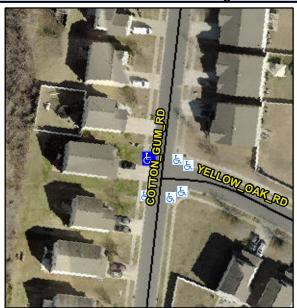
Fleid Measurements/Component Compliance							
Comp	oliance Description	Data	Comp	oliance Description	Data		
N/A	Ramp Length (in)	48.0	Yes	Ramp Slope (%)	6.6		
No	Ramp Width (in)	47.5	Yes	Ramp XSlope (%)	1.6		
N/A	Flare Type LT	N/A	N/A	Flare Type RT	N/A		
N/A	Flare Slope LT (%)	N/A	N/A	Flare Slope RT (%)	N/A		
N/A	Flare Traversable LT?	N/A	N/A	Flare Traversable RT?	N/A		
N/A	Landing Length (in)	N/A	N/A	DWS Provided?	N/A		
N/A	Landing Width (in)	N/A	N/A	DWS Contrast?	N/A		
N/A	Landing Slope (%)	N/A	N/A	DWS Length (in)	N/A		
N/A	Landing X Slope (%)	N/A	N/A	DWS Full Width?	N/A		
N/A	Landing Curb? (Y/N)	N/A	N/A	DWS Offset (in)	N/A		
N/A	Shared Landing?	N/A					
N/A	Gutter Ponding?	N/A	N/A	Gutter Slope (%)	N/A		
N/A	Gutter Lip Ht (in)	N/A	N/A	Gutter X Slope (%)	N/A		
N/A	Painted X Walk1?	No	N/A	Painted X Walk2?	N/A		
	X Walk 1 Direction	To E		X Walk 2 Direction	N/A		
N/A	X Walk 1 Width (in)	N/A	N/A	X Walk 2 Width (in)	N/A

X Walk 1 Slope (%)	2.8		X Walk 2 Slope (%)	N/A		
	X Walk 1 X Slope (%)	1.2		X Walk 2 X Slope (%)	N/A		
N/A	Ramp inside XWalk1?	N/A	N/A	Ramp inside XWalk2?	N/A		
	Road Slope (%)	N/A	N/A	Clear Space?	N/A		
	Road X Slope (%)	N/A	N/A	Clear Space to XWalk (in)	N/A		
N/A	Any Obstructions?	N/A	N/A	Storm Grate/Utility Hazard?	N/A		
	Obstruction Type			Storm Grate/Utility Type			
		N/A			N/A		
			Yes	Surface Condition? (G/P)	Good

ossible Solutions:	<u>c</u>	
Remove & Replace Entire Ramp.		
•	N	
	N	
	N	
	N	
	N	
urveyor Notes:	N	
N/A	N	
	N	
	N	
	N	
ROW/ADA:	N	
Not Found, R304.5.1	N	
	N	
	N	
	N

Total Cost:	\$ 1850.00
