Access Compliance Report

Public Rights-of-Way

(Curb Ramps)

Intersection ID: 25211	Main Street: SMITH_RD	Cross Street: SOUTHBRIDGE_FOREST_DR	Location: SW
ADA ID: 81C83D1E9C44	Ramp Type: BlendTrans2	Initial Pass/Fail: Fail	Overall Compliance: No
		Severity Score: 21.25

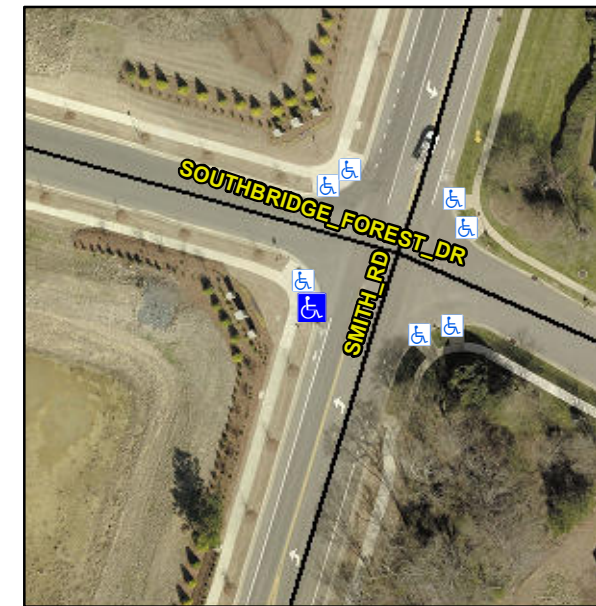
Compliance	Description	Data	Compliance	Description	Data
N/A	Ramp Length (in)	167.0	Yes	BlendTrans Slope (%)	1.0
No	Ramp Width (in)	47.0	No	BlendTrans XSlope (%)	5.1
N/A	Flare Type LT	N/A	N/A	Flare Type RT	N/A
N/A	Flare Slope LT (%)	N/A	N/A	Flare Slope RT (%)	N/A
N/A	Flare Traversable LT?	N/A	N/A	Flare Traversable RT?	N/A
N/A	Landing Length (in)	N/A	N/A	DWS Provided?	N/A
N/A	Landing Width (in)	N/A	N/A	DWS Contrast?	N/A
N/A	Landing Slope (%)	N/A	N/A	DWS Length (in)	N/A
N/A	Landing X Slope (%)	N/A	N/A	DWS Full Width?	N/A
N/A	Landing Curb? (Y/N)	N/A	N/A	DWS Offset (in)	N/A
N/A	Shared Landing?	N/A			
N/A	Gutter Ponding?	N/A	N/A	Gutter Slope (%)	N/A
N/A	Gutter Lip Ht (in)	N/A	N/A	Gutter X Slope (%)	N/A
N/A	Painted X Walk1?	No	N/A	Painted X Walk2?	N/A
	X Walk 1 Direction	To SE		X Walk 2 Direction	N/A
	X Walk 1 Width (in)	N/A		X Walk 2 Width (in)	N/A
	X Walk 1 Slope (%)	1.3		X Walk 2 Slope (%)	N/A
	X Walk 1 X Slope (%)	2.6		X Walk 2 X Slope (%)	N/A

N/A	Ramp inside XWalk1?	N/A	N/A	Ramp inside XWalk2?	N/A
	Road Slope (%)	2.6		Clear Space?	N/A
	Road X Slope (%)	1.3	N/A	Clear Space to XWalk (in)	N/A
N/A	Any Obstructions?	N/A	N/A	Storm Grate/Utility Hazard?	N/A
	Obstruction Type			Storm Grate/Utility Type	
		N/A			N/A
			Yes	Surface Condition? (G/P)	Good
			N/A	Curb Slope (%)	2.7

Remove & Replace Curb Ramp With Two New Directional Ramps or Equivalent.
