# Access Compliance Report

## Public Rights-of-Way

### (Curb Ramps)

| Intersection ID: 49184 | Main Street: ST_GERMAINE_LN | Cross Street: ST_STEPHEN_LN | Location: NW |

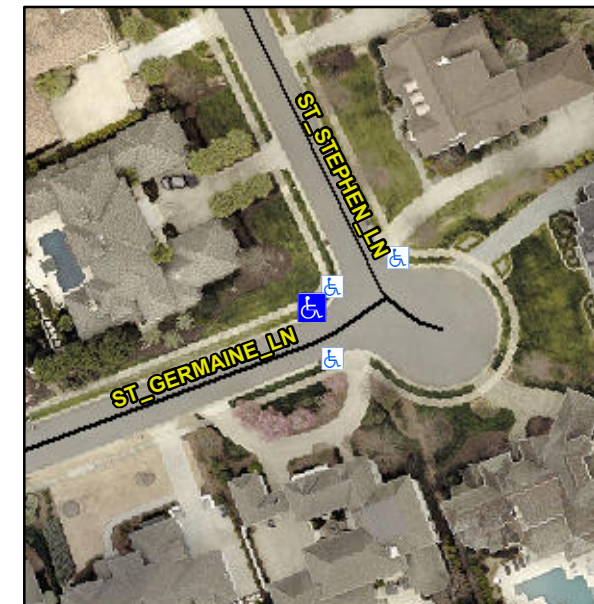
**Not Found, R304.2.2**

| Compliance | Description | Data | Compliance | Description | Data |
|---|---|---|---|---|---|
| N/A | Ramp Length (in) | 48.5 | No | Ramp Slope (%) | 10.7 |

**Remove & Replace Entire Ramp.**
