Access Compliance Report

Public Rights-of-Way

(Curb Ramps)

Intersection ID: 10014556	Main Street: HARRIS_CENTER_DR	Cross Street: N/A	Location: E
ADA ID: 81D0D068FC01	Ramp Type: Perp	Initial Pass/Fail: Fail	Overall Compliance: No
Severity Score: 55			
Codes/Mitigation Info/Possible Solution		Field Measurements/Component Compliance

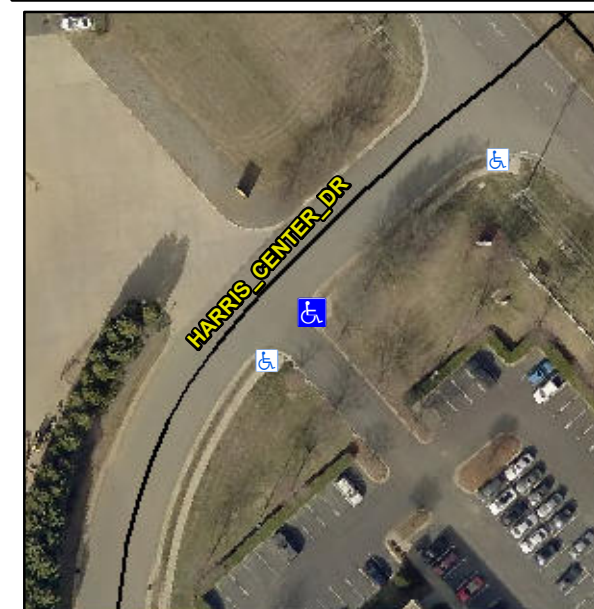
Not Found, R304.5.1, R304.2.2, R304.5.3

Compliance	Description	Data	Compliance	Description	Data
N/A	Ramp Length (in)	47.0	No	Ramp Slope (%)	9.9
No	Ramp Width (in)	34.0	No	Ramp XSlope (%)	11.1
N/A	Flare Type LT	N/A	N/A	Flare Type RT	N/A
N/A	Flare Slope LT (%)	N/A	N/A	Flare Slope RT (%)	N/A
N/A	Flare Traversable LT?	N/A	N/A	Flare Traversable RT?	N/A
N/A	Landing Length (in)	N/A	N/A	DWS Provided?	N/A
N/A	Landing Width (in)	N/A	N/A	DWS Contrast?	N/A
N/A	Landing Slope (%)	N/A	N/A	DWS Length (in)	N/A
N/A	Landing X Slope (%)	N/A	N/A	DWS Full Width?	N/A
N/A	Landing Curb? (Y/N)	N/A	N/A	DWS Offset (in)	N/A
N/A	Shared Landing?	N/A			
N/A	Gutter Ponding?	N/A	N/A	Gutter Slope (%)	N/A
N/A	Gutter Lip Ht (in)	N/A	N/A	Gutter X Slope (%)	N/A
N/A	Painted X Walk1?	No	N/A	Painted X Walk2?	N/A
	X Walk 1 Direction	To SW		X Walk 2 Direction	N/A
N/A	X Walk 1 Width (in)	N/A	N/A	X Walk 2 Width (in)	N/A
	X Walk 1 Slope (%)	4.8		X Walk 2 Slope (%)	N/A
	X Walk 1 X Slope (%)	7.9		X Walk 2 X Slope (%)	N/A

N/A	Ramp inside XWalk1?	N/A	N/A	Ramp inside XWalk2?	N/A
	Road Slope (%)	N/A	N/A	Clear Space?	N/A
	Road X Slope (%)	N/A	N/A	Clear Space to XWalk (in)	N/A
N/A	Any Obstructions?	N/A	N/A	Storm Grate/Utility Hazard?	N/A
	Obstruction Type			Storm Grate/Utility Type	
		N/A			N/A
			Yes	Surface Condition? (G/P)	Good

Possible Solutions:

Remove & Replace Entire Ramp.
