# Access Compliance Report

## Public Rights-of-Way

### (Curb Ramps)

| Intersection ID: 10023519 | Main Street: CLANTON_RD | Cross Street: N/A | Location: S |

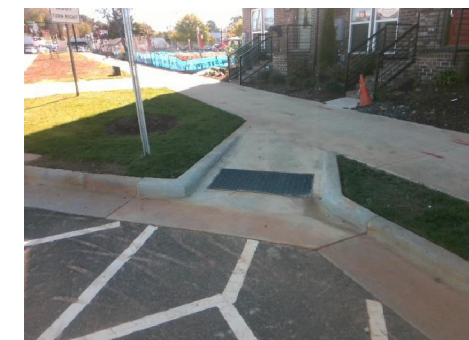
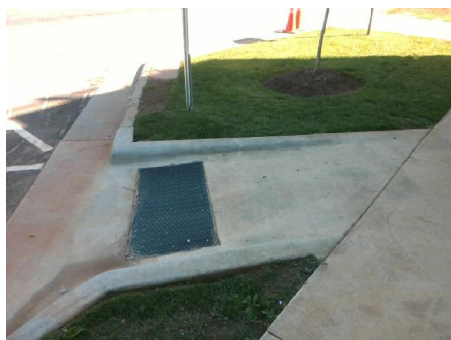
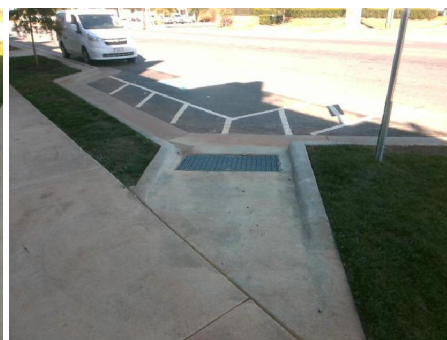
| ADA ID: 81D31B7295EB | Ramp Type: Directional1 | Initial Pass/Fail: Fail | Overall Compliance: No |
| | | Severity Score: 12.5 | |

**ACCESS AISLE RAMP**

| Compliance | Description | Data | Compliance | Description | Data |
|---|---|---|---|---|---|
| No | Ramp Slope (%) | 8.4 | N/A | Grade Break XSlope (%) | 0.0 |

**Remove & Replace Entire Ramp.**

**R304.2.2**

\$ 1600.00
