Access Compliance Report

Public Rights-of-Way

(Curb Ramps)

Intersection ID: 46360	Main Street: GARDNER_LN	Cross Street: GARDNER_POND_CT	Location: SW
ADA ID: 81D61D8E987E	Ramp Type: PerpDiag	Initial Pass/Fail: Fail	Overall Compliance: No
Severity Score: 25			
Codes/Mitigation Info/Possible Solution		Field Measurements/Component Compliance

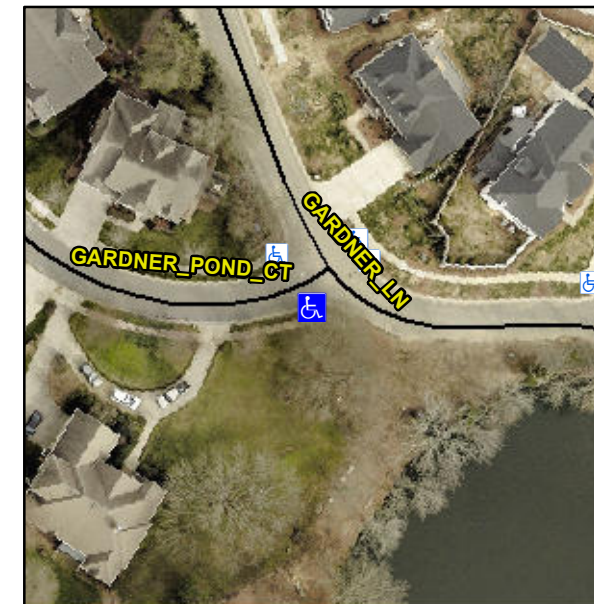
Not Found, R304.2.2, R304.5.3

Compliance	Description	Data	Compliance	Description	Data
N/A	Ramp Length (in)	48.0	No	Ramp Slope (%)	11.0
Yes	Ramp Width (in)	59.0	No	Ramp XSlope (%)	6.3
N/A	Flare Type LT	N/A	N/A	Flare Type RT	N/A
N/A	Flare Slope LT (%)	N/A	N/A	Flare Slope RT (%)	N/A
N/A	Flare Traversable LT?	N/A	N/A	Flare Traversable RT?	N/A
N/A	Landing Length (in)	N/A	N/A	DWS Provided?	N/A
N/A	Landing Width (in)	N/A	N/A	DWS Contrast?	N/A
N/A	Landing Slope (%)	N/A	N/A	DWS Length (in)	N/A
N/A	Landing X Slope (%)	N/A	N/A	DWS Full Width?	N/A
N/A	Landing Curb? (Y/N)	N/A	N/A	DWS Offset (in)	N/A
N/A	Shared Landing?	N/A			
N/A	Gutter Ponding?	N/A	N/A	Gutter Slope (%)	N/A
N/A	Gutter Lip Ht (in)	N/A	N/A	Gutter X Slope (%)	N/A
N/A	Painted X Walk1?	No	N/A	Painted X Walk2?	No
	X Walk 1 Direction	To NE		X Walk 2 Direction	To NW
N/A	X Walk 1 Width (in)	N/A	N/A	X Walk 2 Width (in)	N/A
	X Walk 1 Slope (%)	6.4		X Walk 2 Slope (%)	0.2
	X Walk 1 X Slope (%)	1.0		X Walk 2 X Slope (%)	6.4

N/A	Ramp inside XWalk1?	N/A	N/A	Ramp inside XWalk2?	N/A
	Road Slope (%)	5.0	N/A	Clear Space?	N/A
	Road X Slope (%)	3.4	N/A	Clear Space to XWalk (in)	N/A
N/A	Any Obstructions?	N/A	N/A	Storm Grate/Utility Hazard?	N/A
	Obstruction Type			Storm Grate/Utility Type	
		N/A			N/A
			Yes	Surface Condition? (G/P)	Good

Remove & Replace Curb Ramp With Two New Directional Ramps or Equivalent.
