Access Compliance Report Public Rights-of-Way (Curb Ramps)

Intersection ID: 43475Main Street: LIONS_MANE_STCross Street: LIONS_PAW_STLocation:NEADA ID: 81F049F819A9Ramp Type: PerpDiagInitial Pass/Fail: Fail Overall Compliance: NoSeverity Score: 30

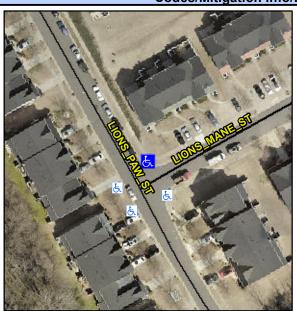
Field Measurements/Component Compliance							
9	Compliance Description		Data	Compl	iance	Description	Data
1	N/A	Ramp Length (in)	50.0	No	Ramp	Slope (%)	10.6
1	No	Ramp Width (in)	34.0	Yes	Ramp	XSlope (%)	1.0
N	N/A	Flare Type LT	N/A	N/A	Flare	Type RT	N/A
1	N/A	Flare Slope LT (%)	N/A	N/A	Flare	Slope RT (%)	N/A
1	N/A	Flare Traversable LT?	N/A	N/A	Flare	Traversable RT?	N/A
1	N/A	Landing Length (in)	N/A	N/A	DWS	Provided?	N/A
1	N/A	Landing Width (in)	N/A	N/A	DWS	Contrast?	N/A
1	N/A	Landing Slope (%)	N/A	N/A	DWS	Length (in)	N/A
1	N/A	Landing X Slope (%)	N/A	N/A	DWS	Full Width?	N/A
1	N/A	Landing Curb? (Y/N)	N/A	N/A	DWS	Offset (in)	N/A
1	N/A	Shared Landing?	N/A				
1	N/A	Gutter Ponding?	N/A	N/A	Gutte	r Slope (%)	N/A
١	N/A	Gutter Lip Ht (in)	N/A	N/A	Gutte	r X Slope (%)	N/A
1	N/A	Painted X Walk1?	No	N/A	Painte	ed X Walk2?	No
		X Walk 1 Direction	To W		X Wa	lk 2 Direction	To S
1	N/A	X Walk 1 Width (in)	N/A	N/A	X Wa	lk 2 Width (in)	N/A

X Walk 1 Slope (%)	3.6		X Wa	lk 2 Slope (%)	3.4
		X Walk 1 X Slope (%)	1.9		X Wa	lk 2 X Slope (%)	0.0
1	N/A	Ramp inside XWalk1?	N/A	N/A	Ramp	inside XWalk2?	N/A
		Road Slope (%)	0.7	N/A	Clear	Space?	N/A
		Road X Slope (%)	3.2	N/A	Clear	Space to XWalk (in)	N/A
ı	N/A	Any Obstructions?	N/A	N/A	Storm	Grate/Utility Hazard?	N/A
		Obstruction Type			Storm	Grate/Utility Type	
			N/A				N/A
				Yes	Surfa	ce Condition? (G/P)	Good

LIONS PAW ST None LIONS MANE ST StopSign Possible Solutions:

Remove & Replace Curb Ramp With Two New Directional Ramps or Equivalent.

R304.5.1, R304.2.2
