Access Compliance Report

Public Rights-of-Way

(Curb Ramps)

Intersection ID: N/A	Main Street: FAIRVIEW_RD	Cross Street: PROVIDENCE_RD	Location: SW
ADA ID: 8202E1D37AF7	Ramp Type: Perp	Initial Pass/Fail: Fail	Overall Compliance: No
Codes/Mitigation Info/Possible Solution		Field Measurements/Component Compliance	
Severity Score: 48.75

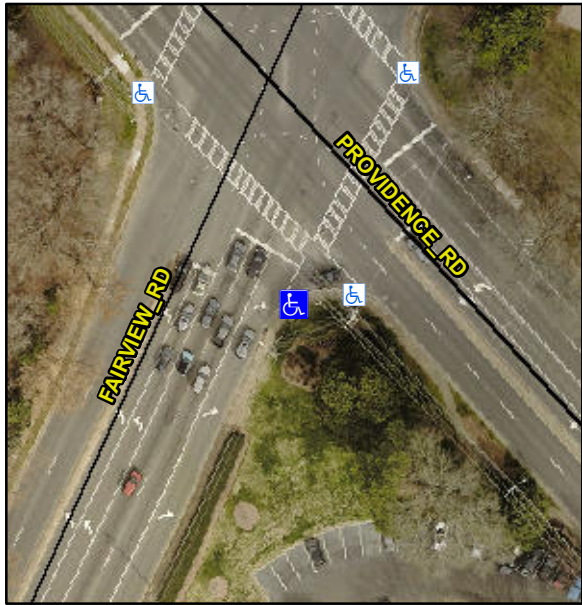
Not Found, R304.5.1, R304.2.2, R304.5.3

Compliance	Description	Data	Compliance	Description	Data
N/A	Ramp Length (in)	59.0	No	Ramp Slope (%)	9.0
No	Ramp Width (in)	31.0	No	Ramp XSlope (%)	2.1
N/A	Flare Type LT	N/A	N/A	Flare Type RT	N/A
N/A	Flare Slope LT (%)	N/A	N/A	Flare Slope RT (%)	N/A
N/A	Flare Traversable LT?	N/A	N/A	Flare Traversable RT?	N/A
N/A	Landing Length (in)	N/A	N/A	DWS Provided?	N/A
N/A	Landing Width (in)	N/A	N/A	DWS Contrast?	N/A
N/A	Landing Slope (%)	N/A	N/A	DWS Length (in)	N/A
N/A	Landing X Slope (%)	N/A	N/A	DWS Full Width?	N/A
N/A	Landing Curb? (Y/N)	N/A	N/A	DWS Offset (in)	N/A
N/A	Shared Landing?	N/A			
N/A	Gutter Ponding?	N/A	N/A	Gutter Slope (%)	N/A
N/A	Gutter Lip Ht (in)	N/A	N/A	Gutter X Slope (%)	N/A
N/A	Painted X Walk1?	Yes	N/A	Painted X Walk2?	N/A
	X Walk 1 Direction	To NW		X Walk 2 Direction	N/A
N/A	X Walk 1 Width (in)	110.0	N/A	X Walk 2 Width (in)	N/A
	X Walk 1 Slope (%)	3.5		X Walk 2 Slope (%)	N/A
	X Walk 1 X Slope (%)	1.2		X Walk 2 X Slope (%)	N/A

N/A	Ramp inside XWalk1?	Yes	N/A	Ramp inside XWalk2?	N/A
	Road Slope (%)	N/A	N/A	Clear Space?	N/A
	Road X Slope (%)	N/A	N/A	Clear Space to XWalk (in)	N/A
N/A	Any Obstructions?	N/A	N/A	Storm Grate/Utility Hazard?	N/A
	Obstruction Type			Storm Grate/Utility Type	
		N/A			N/A
			Yes	Surface Condition? (G/P)	Good

Remove & Replace Entire Ramp.
