# Access Compliance Report

## Public Rights-of-Way

### (Curb Ramps)

Intersection ID: 10015635	Main Street: HARRIS_CORNERS_PY	Cross Street: N/A	Location: S
ADA ID: 8203A1C7973E	Ramp Type: BlendTrans2	Initial Pass/Fail: Fail	Overall Compliance: No
		Severity Score: 10

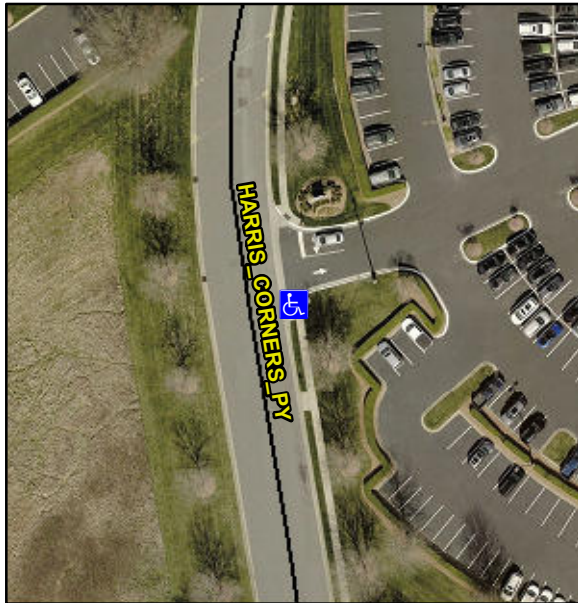
Compliance	Description	Data	Compliance	Description	Data
N/A	Ramp Length (in)	<b>60.0</b>	Yes	BlendTrans Slope (%)	<b>3.5</b>
No	Ramp Width (in)	<b>42.0</b>	No	BlendTrans XSlope (%)	<b>2.4</b>
N/A	Flare Type LT	<b>N/A</b>	N/A	Flare Type RT	<b>N/A</b>
N/A	Flare Slope LT (%)	<b>N/A</b>	N/A	Flare Slope RT (%)	<b>N/A</b>
N/A	Flare Traversable LT?	<b>N/A</b>	N/A	Flare Traversable RT?	<b>N/A</b>
N/A	Landing Length (in)	<b>N/A</b>	N/A	DWS Provided?	<b>N/A</b>
N/A	Landing Width (in)	<b>N/A</b>	N/A	DWS Contrast?	<b>N/A</b>
N/A	Landing Slope (%)	<b>N/A</b>	N/A	DWS Length (in)	<b>N/A</b>
N/A	Landing X Slope (%)	<b>N/A</b>	N/A	DWS Full Width?	<b>N/A</b>
N/A	Landing Curb? (Y/N)	<b>N/A</b>	N/A	DWS Offset (in)	<b>N/A</b>
N/A	Shared Landing?	<b>N/A</b>			
N/A	Gutter Ponding?	<b>N/A</b>	N/A	Gutter Slope (%)	<b>N/A</b>
N/A	Gutter Lip Ht (in)	<b>N/A</b>	N/A	Gutter X Slope (%)	<b>N/A</b>
N/A	Painted X Walk1?	<b>No</b>	N/A	Painted X Walk2?	<b>No</b>

X Walk 1 Direction	<b>To W</b>		X Walk 2 Direction	<b>To N</b>
	X Walk 1 Width (in)	<b>N/A</b>		X Walk 2 Width (in)	<b>N/A</b>
	X Walk 1 Slope (%)	<b>3.9</b>		X Walk 2 Slope (%)	<b>2.4</b>
	X Walk 1 X Slope (%)	<b>1.3</b>		X Walk 2 X Slope (%)	<b>2.4</b>
N/A	Ramp inside XWalk1?	<b>N/A</b>	N/A	Ramp inside XWalk2?	<b>N/A</b>
	Road Slope (%)	<b>2.0</b>		Clear Space?	<b>N/A</b>
	Road X Slope (%)	<b>0.8</b>	N/A	Clear Space to XWalk (in)	<b>N/A</b>
N/A	Any Obstructions?	<b>N/A</b>	N/A	Storm Grate/Utility Hazard?	<b>N/A</b>
	Obstruction Type			Storm Grate/Utility Type	
		<b>N/A</b>			<b>N/A</b>
			Yes	Surface Condition? (G/P)	<b>Good</b>
			N/A	Curb Slope (%)	<b>1.0</b>

**Remove & Replace Curb Ramp With Two New Directional Ramps or Equivalent.**

**R304.5.1, R304.5.3**
