## Access Compliance Report Public Rights-of-Way (Curb Ramps)

Intersection ID: N/A Main Street: PENCE\_POND\_LN Cross Street: PENCE\_RD Location: NW

ADA ID: 820F342212BE Ramp Type: Combination2 Initial Pass/Fail: Fail Overall Compliance: No Severity Score: 13.75

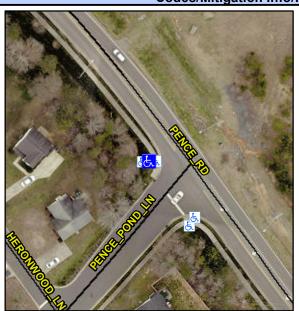
N/A	Ramp Length (in)	69.5	Yes	Ramp Slope (%)	5.0
No	Ramp Width (in)	30.0	No	Ramp XSlope (%)	2.1
N/A	Flare Type LT	N/A	N/A	Flare Type RT	N/A
N/A	Flare Slope LT (%)	N/A	N/A	Flare Slope RT (%)	N/A
N/A	Flare Traversable LT?	N/A	N/A	Flare Traversable RT?	N/A
N/A	Landing Length (in)	N/A	N/A	DWS Provided?	N/A
N/A	Landing Width (in)	N/A	N/A	DWS Contrast?	N/A
N/A	Landing Slope (%)	N/A	N/A	DWS Length (in)	N/A
N/A	Landing X Slope (%)	N/A	N/A	DWS Full Width?	N/A
N/A	Landing Curb? (Y/N)	N/A	N/A	DWS Offset (in)	N/A
N/A	Shared Landing?	N/A			
N/A	Gutter Ponding?	N/A	N/A	Gutter Slope (%)	N/A
N/A	Gutter Lip Ht (in)	N/A	N/A	Gutter X Slope (%)	N/A
N/A	Painted X Walk1?	No	N/A	Painted X Walk2?	N/A
	X Walk 1 Direction	To SE		X Walk 2 Direction	N/A
	X Walk 1 Width (in)	N/A		X Walk 2 Width (in)	N/A
	X Walk 1 Slope (%)	3.8		X Walk 2 Slope (%)	N/A
	X Walk 1 X Slope (%)	2.5		X Walk 2 X Slope (%)	N/A
N/A	Ramp inside XWalk1?	N/A	N/A	Ramp inside XWalk2?	N/A

"	1 CSSIDIC COIDLIOII
-	Possible Solutions:
	Remove & Replace Entire Ramp.
1	
Section 2	
	Surveyor Notes:
THE PERSON	N/A
	N/A
The said	
	PROW/ADA:
N	Not Found, R304.5.1, R304.5.3,
	R304.3.2
V
