Access Compliance Report

Public Rights-of-Way

(Curb Ramps)

Intersection ID: 47400	Main Street: OVERLAND_PARK_LN	Cross Street: FLAT_RIVER_DR	Location: NW
ADA ID: 82113B934289	Ramp Type: Perp	Initial Pass/Fail: Fail	Overall Compliance: No
Severity Score: 26.25			
Codes/Mitigation Info/Possible Solution		Field Measurements/Component Compliance

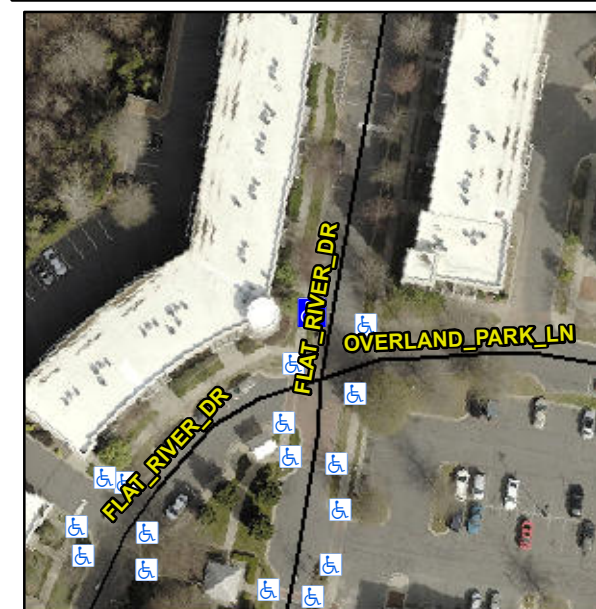
Compliance	Description	Data	Compliance	Description	Data
N/A	Ramp Length (in)	57.0	No	Ramp Slope (%)	12.1
Yes	Ramp Width (in)	50.5	No	Ramp XSlope (%)	2.3
N/A	Flare Type LT	N/A	N/A	Flare Type RT	N/A
N/A	Flare Slope LT (%)	N/A	N/A	Flare Slope RT (%)	N/A
N/A	Flare Traversable LT?	N/A	N/A	Flare Traversable RT?	N/A
N/A	Landing Length (in)	N/A	N/A	DWS Provided?	N/A
N/A	Landing Width (in)	N/A	N/A	DWS Contrast?	N/A
N/A	Landing Slope (%)	N/A	N/A	DWS Length (in)	N/A
N/A	Landing X Slope (%)	N/A	N/A	DWS Full Width?	N/A
N/A	Landing Curb? (Y/N)	N/A	N/A	DWS Offset (in)	N/A
N/A	Shared Landing?	N/A			
N/A	Gutter Ponding?	N/A	N/A	Gutter Slope (%)	N/A
N/A	Gutter Lip Ht (in)	N/A	N/A	Gutter X Slope (%)	N/A
N/A	Painted X Walk1?	Yes	N/A	Painted X Walk2?	N/A
	X Walk 1 Direction	To SE		X Walk 2 Direction	N/A
N/A	X Walk 1 Width (in)	51.0	N/A	X Walk 2 Width (in)	N/A
	X Walk 1 Slope (%)	0.9		X Walk 2 Slope (%)	N/A
	X Walk 1 X Slope (%)	1.8		X Walk 2 X Slope (%)	N/A

N/A	Ramp inside XWalk1?	Yes	N/A	Ramp inside XWalk2?	N/A
	Road Slope (%)	N/A	N/A	Clear Space?	N/A
	Road X Slope (%)	N/A	N/A	Clear Space to XWalk (in)	N/A
N/A	Any Obstructions?	N/A	N/A	Storm Grate/Utility Hazard?	N/A
	Obstruction Type			Storm Grate/Utility Type	
		N/A			N/A
		Yes		Surface Condition? (G/P)	Good

Possible Solutions:

Remove & Replace Entire Ramp.

R304.2.2, R304.5.3
