# Access Compliance Report

## Public Rights-of-Way

### (Curb Ramps)

Intersection ID: 45220	Main Street: ARDREY_KELL_RD	Cross Street: HARCOTBE_DR	Location: SE
ADA ID: 821DE2D3D083	Ramp Type: Perp	Initial Pass/Fail: Fail	Overall Compliance: No
		Severity Score: 12.5

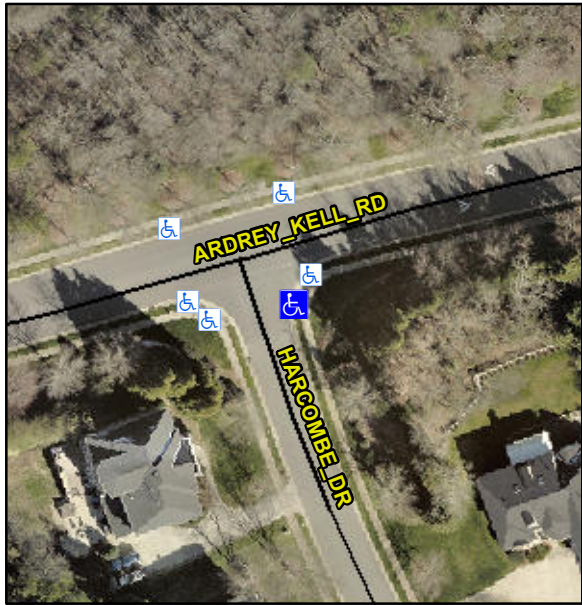
Possible Solutions:		<b>Compliance</b>	<b>Description</b>	<b>Data</b>	<b>Compliance</b>	<b>Description</b>	<b>Data</b>
	<b>Remove &amp; Replace Entire Ramp.</b>		N/A	Ramp Length (in)	49.0	No	Ramp Slope (%)	9.0
			Yes	Ramp Width (in)	48.0	Yes	Ramp XSlope (%)	1.9
			N/A	Flare Type LT	N/A	N/A	Flare Type RT	N/A
			N/A	Flare Slope LT (%)	N/A	N/A	Flare Slope RT (%)	N/A
			N/A	Flare Traversable LT?	N/A	N/A	Flare Traversable RT?	N/A
			N/A	Landing Length (in)	N/A	N/A	DWS Provided?	N/A
			N/A	Landing Width (in)	N/A	N/A	DWS Contrast?	N/A
			N/A	Landing Slope (%)	N/A	N/A	DWS Length (in)	N/A
			N/A	Landing X Slope (%)	N/A	N/A	DWS Full Width?	N/A
Surveyor Notes:			N/A	Landing Curb? (Y/N)	N/A	N/A	DWS Offset (in)	N/A
PROW/ADA:			N/A	Shared Landing?	N/A			
<b>Not Found, R304.2.2</b>			N/A	Gutter Ponding?	N/A	N/A	Gutter Slope (%)	N/A

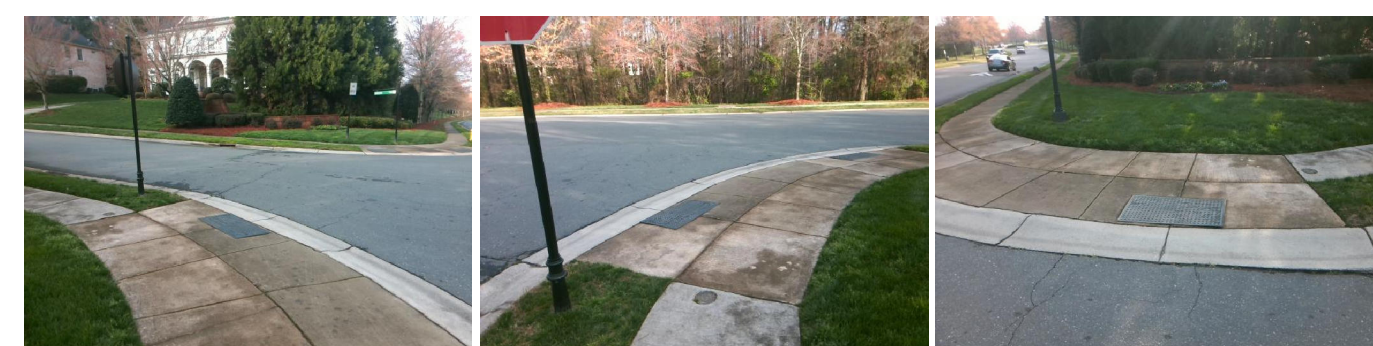
N/A	Gutter Lip Ht (in)	N/A	N/A	Gutter X Slope (%)	N/A
			N/A	Painted X Walk1?	No	N/A	Painted X Walk2?	N/A
				X Walk 1 Direction	To W		X Walk 2 Direction	N/A
			N/A	X Walk 1 Width (in)	N/A	N/A	X Walk 2 Width (in)	N/A
				X Walk 1 Slope (%)	0.8		X Walk 2 Slope (%)	N/A
				X Walk 1 X Slope (%)	2.3		X Walk 2 X Slope (%)	N/A
			N/A	Ramp inside XWalk1?	N/A	N/A	Ramp inside XWalk2?	N/A
				Road Slope (%)	N/A	N/A	Clear Space?	N/A
				Road X Slope (%)	N/A	N/A	Clear Space to XWalk (in)	N/A
			N/A	Any Obstructions?	N/A	N/A	Storm Grate/Utility Hazard?	N/A
				Obstruction Type			Storm Grate/Utility Type	
					N/A			N/A
						Yes	Surface Condition? (G/P)	Good
Total Cost:		\$	1850.00					
Street 1 Name		HARCOMBE DR						
Stop Condition-Street 2		StopSign						
Street 2 Name		N/A						
Stop Condition-Street 1		N/A
