Access Compliance Report

Public Rights-of-Way

(Curb Ramps)

Intersection ID: 8459	Main Street: KENTBROOK_DR	Cross Street: SPRINGVIEW_RD	Location: SE
ADA ID: 822022DD3EDD	Ramp Type: Perp	Initial Pass/Fail: Fail	Overall Compliance: No
Severity Score: 31.25			
Codes/Mitigation Info/Possible Solution		Field Measurements/Component Compliance

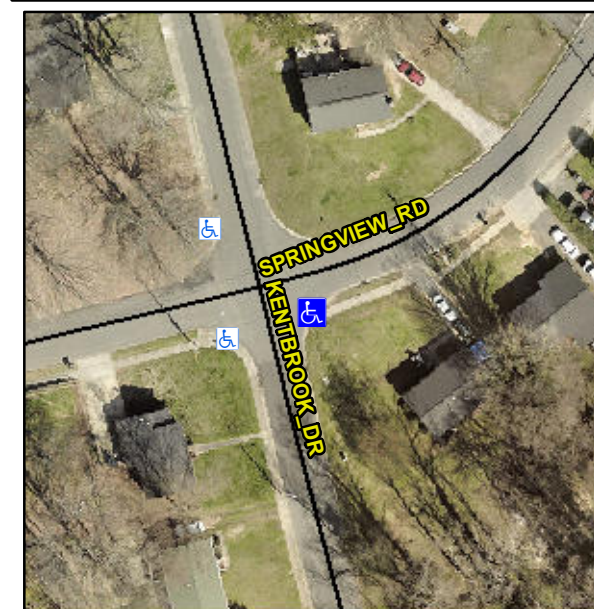
Not Found, R304.5.1, R304.2.2

Compliance	Description	Data	Compliance	Description	Data
N/A	Ramp Length (in)	73.5	No	Ramp Slope (%)	9.1
No	Ramp Width (in)	35.0	Yes	Ramp XSlope (%)	3.5
N/A	Flare Type LT	N/A	N/A	Flare Type RT	N/A
N/A	Flare Slope LT (%)	N/A	N/A	Flare Slope RT (%)	N/A
N/A	Flare Traversable LT?	N/A	N/A	Flare Traversable RT?	N/A
N/A	Landing Length (in)	N/A	N/A	DWS Provided?	N/A
N/A	Landing Width (in)	N/A	N/A	DWS Contrast?	N/A
N/A	Landing Slope (%)	N/A	N/A	DWS Length (in)	N/A
N/A	Landing X Slope (%)	N/A	N/A	DWS Full Width?	N/A
N/A	Landing Curb? (Y/N)	N/A	N/A	DWS Offset (in)	N/A
N/A	Shared Landing?	N/A			
N/A	Gutter Ponding?	N/A	N/A	Gutter Slope (%)	N/A
N/A	Gutter Lip Ht (in)	1.0	N/A	Gutter X Slope (%)	N/A
N/A	Painted X Walk1?	No	N/A	Painted X Walk2?	N/A
	X Walk 1 Direction	To W		X Walk 2 Direction	N/A
N/A	X Walk 1 Width (in)	N/A	N/A	X Walk 2 Width (in)	N/A
	X Walk 1 Slope (%)	1.5		X Walk 2 Slope (%)	N/A
	X Walk 1 X Slope (%)	7.0		X Walk 2 X Slope (%)	N/A

N/A	Ramp inside XWalk1?	N/A	N/A	Ramp inside XWalk2?	N/A
	Road Slope (%)	N/A	N/A	Clear Space?	N/A
	Road X Slope (%)	N/A	N/A	Clear Space to XWalk (in)	N/A
N/A	Any Obstructions?	N/A	N/A	Storm Grate/Utility Hazard?	N/A
	Obstruction Type			Storm Grate/Utility Type	
		N/A			N/A
			Yes	Surface Condition? (G/P)	Good

Remove & Replace Entire Ramp.
