# Access Compliance Report Public Rights-of-Way (Curb Ramps)

Intersection ID: 10029691	Main Street: KINGSLEY_VIEW_DR	Cross Street: N/A	Location: SW
ADA ID: 82274787CCAF	Ramp Type: BlendTrans1	Initial Pass/Fail: Fail	Overall Compliance: No Severity Score: 18.75

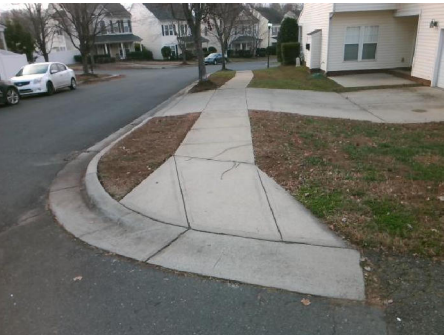
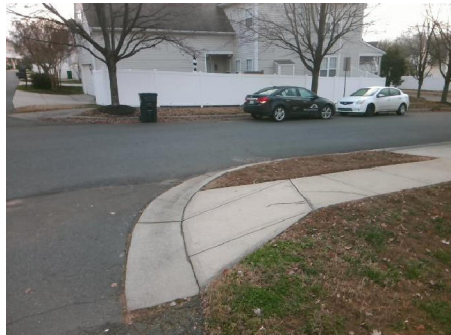
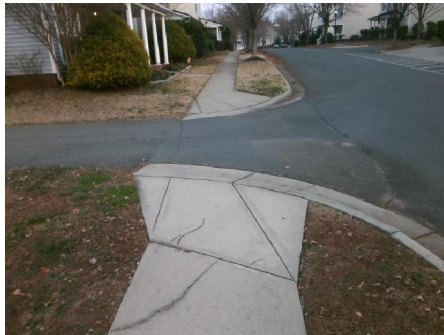
PROW/ADA:  
**Not Found, R304.5.1, R304.5.3**

Compliance	Description	Data	Compliance	Description	Data
N/A	Ramp Length (in)	66.0	Yes	BlendTrans Slope (%)	2.5
No	Ramp Width (in)	35.0	No	BlendTrans XSlope (%)	2.4
N/A	Flare Type LT	N/A	N/A	Flare Type RT	N/A
N/A	Flare Slope LT (%)	N/A	N/A	Flare Slope RT (%)	N/A
N/A	Flare Traversable LT?	N/A	N/A	Flare Traversable RT?	N/A
N/A	Landing Length (in)	N/A	N/A	DWS Provided?	N/A
N/A	Landing Width (in)	N/A	N/A	DWS Contrast?	N/A
N/A	Landing Slope (%)	N/A	N/A	DWS Length (in)	N/A
N/A	Landing X Slope (%)	N/A	N/A	DWS Full Width?	N/A
N/A	Landing Curb? (Y/N)	N/A	N/A	DWS Offset (in)	N/A
N/A	Shared Landing?	N/A			
N/A	Gutter Ponding?	N/A	N/A	Gutter Slope (%)	N/A
N/A	Gutter Lip Ht (in)	N/A	N/A	Gutter X Slope (%)	N/A
N/A	Painted X Walk1?	No	N/A	Painted X Walk2?	No
	X Walk 1 Direction	To E		X Walk 2 Direction	To N
	X Walk 1 Width (in)	N/A		X Walk 2 Width (in)	N/A
	X Walk 1 Slope (%)	1.0		X Walk 2 Slope (%)	1.5
	X Walk 1 X Slope (%)	0.7		X Walk 2 X Slope (%)	0.4

N/A	Ramp inside XWalk1?	N/A	N/A	Ramp inside XWalk2?	N/A
	Road Slope (%)	2.0		Clear Space?	N/A
	Road X Slope (%)	1.1	N/A	Clear Space to XWalk (in)	N/A
N/A	Any Obstructions?	N/A	N/A	Storm Grate/Utility Hazard?	N/A
	Obstruction Type			Storm Grate/Utility Type	
		N/A			N/A
Yes	Surface Condition? (G/P)		Yes		Good
No	Curb Slope (%)		No		9.7

Possible Solutions:  
**Remove & Replace Curb Ramp With Two New Directional Ramps or Equivalent.**
