# Access Compliance Report

## Public Rights-of-Way

Intersection ID: 47107	Main Street: ERNEST_RUSSELL_CT	Cross Street: HATTIE_LITTLE_ST	Location: SE
ADA ID: 82442A111ED0	Ramp Type: PerpDiag	Initial Pass/Fail: Fail	Overall Compliance: No
Severity Score: 21.25			
Codes/Mitigation Info/Possible Solution		Field Measurements/Component Compliance

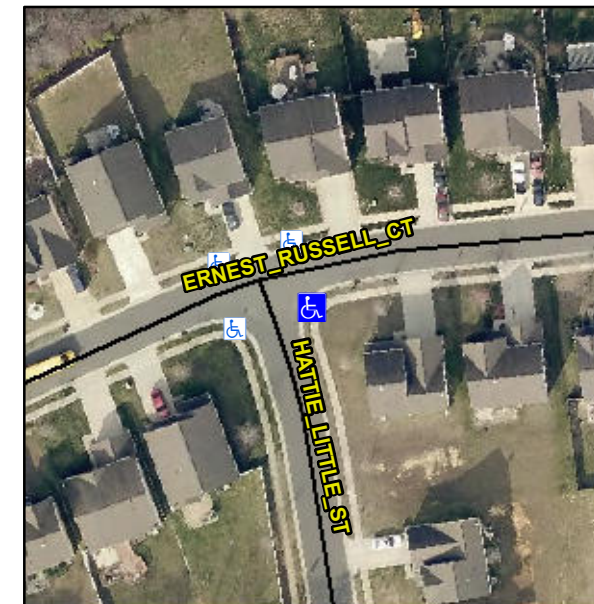
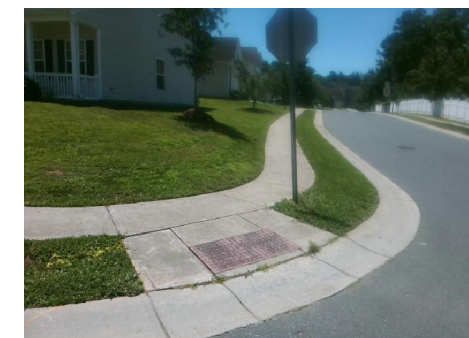
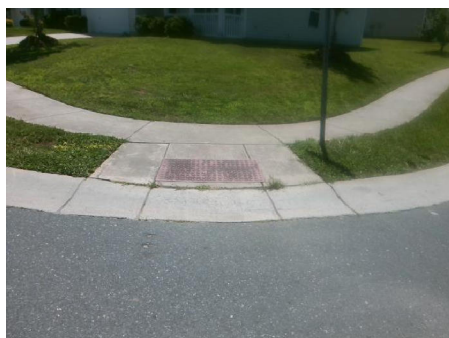
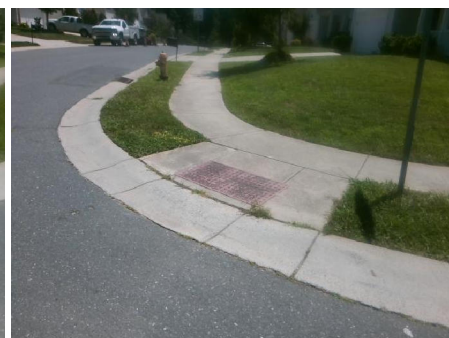
Compliance	Description	Data	Compliance	Description	Data
N/A	Ramp Length (in)	49.0	No	Ramp Slope (%)	10.5
No	Ramp Width (in)	41.0	Yes	Ramp XSlope (%)	1.3
N/A	Flare Type LT	N/A	N/A	Flare Type RT	N/A
N/A	Flare Slope LT (%)	N/A	N/A	Flare Slope RT (%)	N/A
N/A	Flare Traversable LT?	N/A	N/A	Flare Traversable RT?	N/A
N/A	Landing Length (in)	N/A	N/A	DWS Provided?	N/A
N/A	Landing Width (in)	N/A	N/A	DWS Contrast?	N/A
N/A	Landing Slope (%)	N/A	N/A	DWS Length (in)	N/A
N/A	Landing X Slope (%)	N/A	N/A	DWS Full Width?	N/A
N/A	Landing Curb? (Y/N)	N/A	N/A	DWS Offset (in)	N/A
N/A	Shared Landing?	N/A			
N/A	Gutter Ponding?	N/A	N/A	Gutter Slope (%)	N/A
N/A	Gutter Lip Ht (in)	N/A	N/A	Gutter X Slope (%)	N/A
N/A	Painted X Walk1?	No	N/A	Painted X Walk2?	No
	X Walk 1 Direction	To N		X Walk 2 Direction	To W
N/A	X Walk 1 Width (in)	N/A	N/A	X Walk 2 Width (in)	N/A
	X Walk 1 Slope (%)	2.6		X Walk 2 Slope (%)	0.8
	X Walk 1 X Slope (%)	1.6		X Walk 2 X Slope (%)	0.9

N/A	Ramp inside XWalk1?	N/A	N/A	Ramp inside XWalk2?	N/A
	Road Slope (%)	1.3	N/A	Clear Space?	N/A
	Road X Slope (%)	0.1	N/A	Clear Space to XWalk (in)	N/A
N/A	Any Obstructions?	N/A	N/A	Storm Grate/Utility Hazard?	N/A
	Obstruction Type			Storm Grate/Utility Type	
		N/A			N/A
		Yes		Surface Condition? (G/P)	Good

**Remove & Replace Curb Ramp With Two New Directional Ramps or Equivalent.**

**R304.5.1, R304.2.2**
