Access Compliance Report Public Rights-of-Way (Curb Ramps)

Intersection ID: 11684 Main Street: CARLYLE_DR Cross Street: WILSON_AV Location: S

ADA ID: 8249AFC14874 Ramp Type: Perp Initial Pass/Fail: Fail Overall Compliance: No Severity Score: 21.25

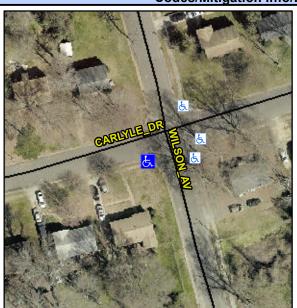
Field Measurements/Component Compliance						
Compli	ance Description	Data	Compl	iance Description	Data	
N/A	Ramp Length (in)	35.0	No	Ramp Slope (%)	8.4	
No	Ramp Width (in)	43.5	Yes	Ramp XSlope (%)	1.6	
N/A	Flare Type LT	N/A	N/A	Flare Type RT	N/A	
N/A	Flare Slope LT (%)	N/A	N/A	Flare Slope RT (%)	N/A	
N/A	Flare Traversable LT?	N/A	N/A	Flare Traversable RT?	N/A	
N/A	Landing Length (in)	N/A	N/A	DWS Provided?	N/A	
N/A	Landing Width (in)	N/A	N/A	DWS Contrast?	N/A	
N/A	Landing Slope (%)	N/A	N/A	DWS Length (in)	N/A	
N/A	Landing X Slope (%)	N/A	N/A	DWS Full Width?	N/A	
N/A	Landing Curb? (Y/N)	N/A	N/A	DWS Offset (in)	N/A	
N/A	Shared Landing?	N/A				
N/A	Gutter Ponding?	N/A	N/A	Gutter Slope (%)	N/A	
N/A	Gutter Lip Ht (in)	N/A	N/A	Gutter X Slope (%)	N/A	
N/A	Painted X Walk1?	No	N/A	Painted X Walk2?	N/A	
	X Walk 1 Direction	To E		X Walk 2 Direction	N/A	
N/A	X Walk 1 Width (in)	N/A	N/A	X Walk 2 Width (in)	N/A	
	X Walk 1 Slope (%)	1.3		X Walk 2 Slope (%)	N/A

X Walk 1 X Slope (%)	2.8		X Walk 2 X Slope (%)	N/A	
N/A	Ramp inside XWalk1?	N/A	N/A	Ramp inside XWalk2?	N/A	
	Road Slope (%)	N/A	N/A	Clear Space?	N/A	
	Road X Slope (%)	N/A	N/A	Clear Space to XWalk (in)	N/A	
N/A	Any Obstructions?	N/A	N/A	Storm Grate/Utility Hazard?	N/A	
	Obstruction Type			Storm Grate/Utility Type		
		N/A			N/A	
			Yes	Surface Condition? (G/P)	Good

Possible Solutions:	
Remove & Replace Entire Ramp.	I
	!
1	
	ı
Surveyor Notes:	ı
N/A	ı
in the second se	
PROW/ADA:	
Not Found, R304.5.1, R304.2.2	ı
	I
	ı
