Access Compliance Report

Public Rights-of-Way

(Curb Ramps)

Intersection ID: 8735	Main Street: GLENWOOD_DR	Cross Street: ROWAN_ST	Location: SW
ADA ID: 824E00BD40A0	Ramp Type: Perp	Initial Pass/Fail: Fail	Overall Compliance: No
Codes/Mitigation Info/Possible Solution		Field Measurements/Component Compliance	
Severity Score: 21.25

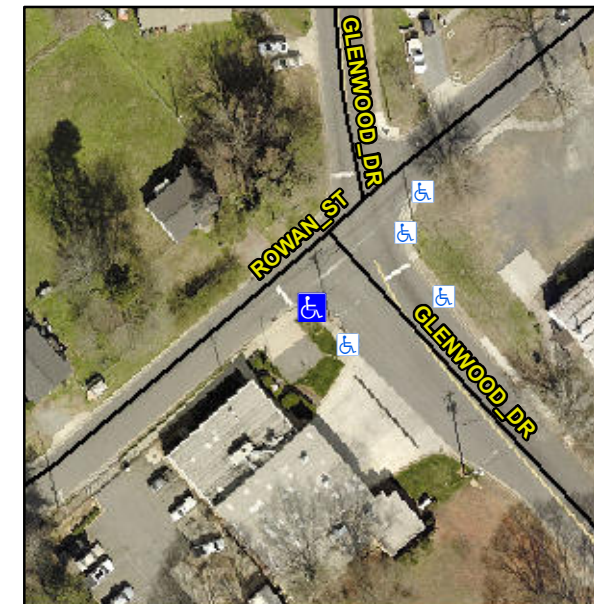
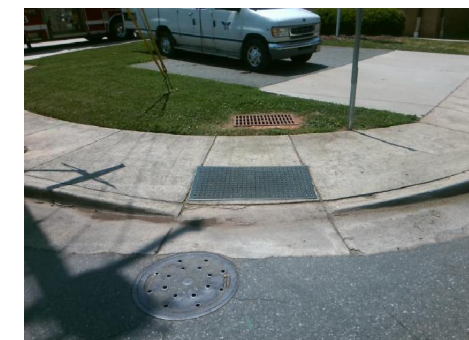
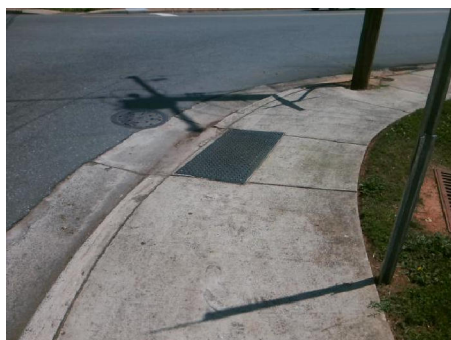
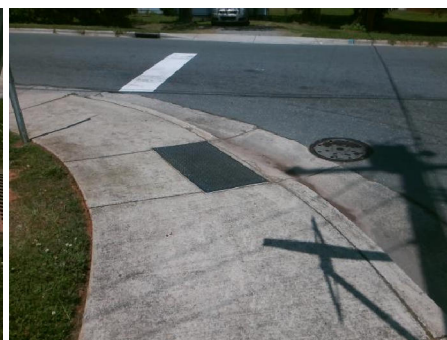
Not Found, R304.5.1, R304.2.2

Compliance	Description	Data	Compliance	Description	Data
N/A	Ramp Length (in)	58.0	No	Ramp Slope (%)	9.8
No	Ramp Width (in)	36.0	Yes	Ramp XSlope (%)	0.9
N/A	Flare Type LT	N/A	N/A	Flare Type RT	N/A
N/A	Flare Slope LT (%)	N/A	N/A	Flare Slope RT (%)	N/A
N/A	Flare Traversable LT?	N/A	N/A	Flare Traversable RT?	N/A
N/A	Landing Length (in)	N/A	N/A	DWS Provided?	N/A
N/A	Landing Width (in)	N/A	N/A	DWS Contrast?	N/A
N/A	Landing Slope (%)	N/A	N/A	DWS Length (in)	N/A
N/A	Landing X Slope (%)	N/A	N/A	DWS Full Width?	N/A
N/A	Landing Curb? (Y/N)	N/A	N/A	DWS Offset (in)	N/A
N/A	Shared Landing?	N/A			
N/A	Gutter Ponding?	N/A	N/A	Gutter Slope (%)	N/A
N/A	Gutter Lip Ht (in)	N/A	N/A	Gutter X Slope (%)	N/A
N/A	Painted X Walk1?	No	N/A	Painted X Walk2?	N/A
	X Walk 1 Direction	To NE		X Walk 2 Direction	N/A
N/A	X Walk 1 Width (in)	N/A	N/A	X Walk 2 Width (in)	N/A
	X Walk 1 Slope (%)	3.0		X Walk 2 Slope (%)	N/A
	X Walk 1 X Slope (%)	1.2		X Walk 2 X Slope (%)	N/A

N/A	Ramp inside XWalk1?	N/A	N/A	Ramp inside XWalk2?	N/A
	Road Slope (%)	N/A	N/A	Clear Space?	N/A
	Road X Slope (%)	N/A	N/A	Clear Space to XWalk (in)	N/A
N/A	Any Obstructions?	N/A	N/A	Storm Grate/Utility Hazard?	N/A
	Obstruction Type			Storm Grate/Utility Type	
		N/A			N/A
			Yes	Surface Condition? (G/P)	Good

Possible Solutions:

Remove & Replace Entire Ramp.
