Access Compliance Report

Public Rights-of-Way

(Curb Ramps)

Intersection ID: 15261	Main Street: FENTON_PL	Cross Street: PROVIDENCE_RD	Location: NE
ADA ID: 8275BC2A907C	Ramp Type: PerpDiag	Initial Pass/Fail: Fail	Overall Compliance: No
Severity Score: 21.25			
Codes/Mitigation Info/Possible Solution		Field Measurements/Component Compliance

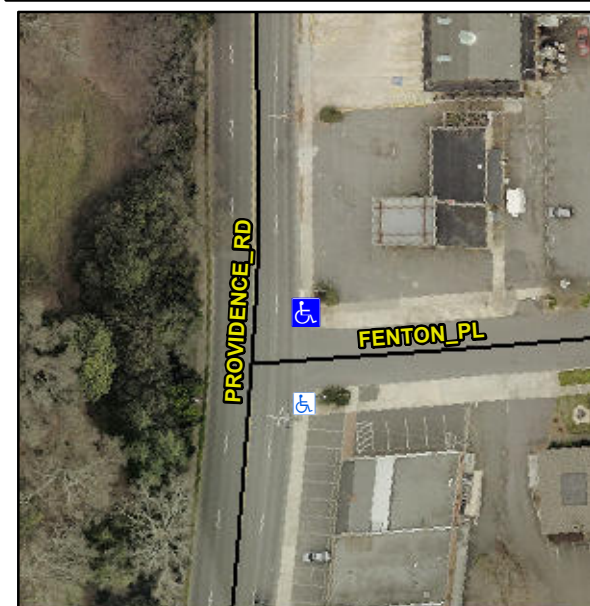
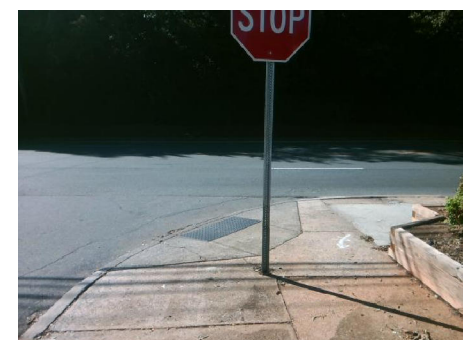
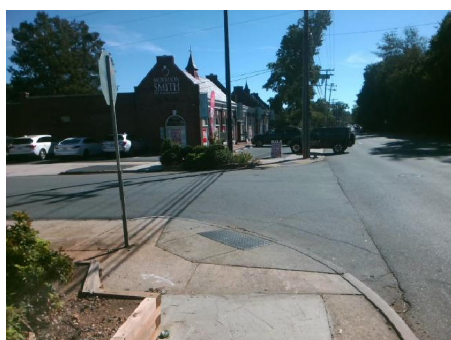
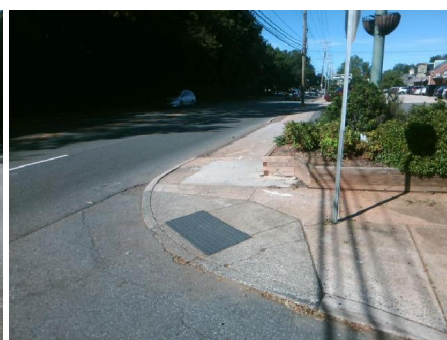
Not Found, R304.5.1, R304.2.2

Compliance	Description	Data	Compliance	Description	Data
N/A	Ramp Length (in)	60.0	No	Ramp Slope (%)	8.5
No	Ramp Width (in)	42.0	Yes	Ramp XSlope (%)	1.2
N/A	Flare Type LT	N/A	N/A	Flare Type RT	N/A
N/A	Flare Slope LT (%)	N/A	N/A	Flare Slope RT (%)	N/A
N/A	Flare Traversable LT?	N/A	N/A	Flare Traversable RT?	N/A
N/A	Landing Length (in)	N/A	N/A	DWS Provided?	N/A
N/A	Landing Width (in)	N/A	N/A	DWS Contrast?	N/A
N/A	Landing Slope (%)	N/A	N/A	DWS Length (in)	N/A
N/A	Landing X Slope (%)	N/A	N/A	DWS Full Width?	N/A
N/A	Landing Curb? (Y/N)	N/A	N/A	DWS Offset (in)	N/A
N/A	Shared Landing?	N/A			
N/A	Gutter Ponding?	N/A	N/A	Gutter Slope (%)	N/A
N/A	Gutter Lip Ht (in)	N/A	N/A	Gutter X Slope (%)	N/A
N/A	Painted X Walk1?	No	N/A	Painted X Walk2?	No
	X Walk 1 Direction	To W		X Walk 2 Direction	To SW
N/A	X Walk 1 Width (in)	N/A	N/A	X Walk 2 Width (in)	N/A
	X Walk 1 Slope (%)	0.9		X Walk 2 Slope (%)	1.8
	X Walk 1 X Slope (%)	0.3		X Walk 2 X Slope (%)	0.2

N/A	Ramp inside XWalk1?	N/A	N/A	Ramp inside XWalk2?	N/A
	Road Slope (%)	0.5	N/A	Clear Space?	N/A
	Road X Slope (%)	1.0	N/A	Clear Space to XWalk (in)	N/A
N/A	Any Obstructions?	N/A	N/A	Storm Grate/Utility Hazard?	N/A
	Obstruction Type			Storm Grate/Utility Type	
		N/A			N/A
		Yes		Surface Condition? (G/P)	Good

Remove & Replace Curb Ramp With Two New Directional Ramps or Equivalent.
