# Access Compliance Report

## Public Rights-of-Way

### (Curb Ramps)

| Intersection ID: 24040 | Main Street: FOX_CHAPEL_LN | Cross Street: HAWK_CREST_CT | Location: S |

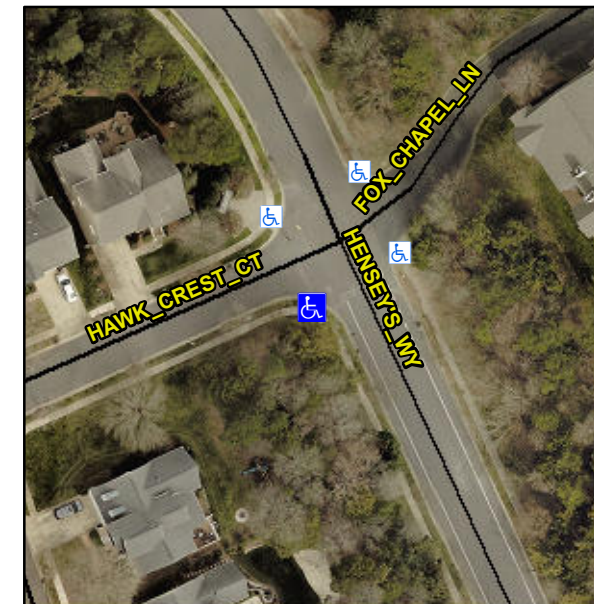
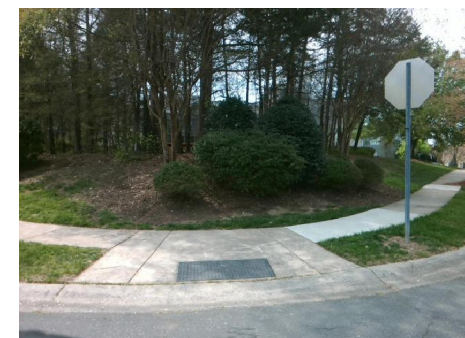
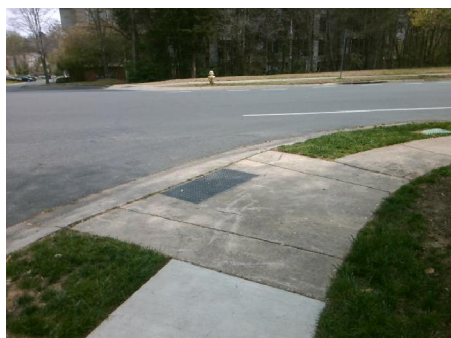
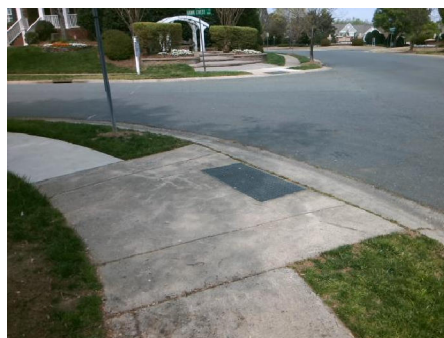
| ADA ID: 827E8874D7DE | Ramp Type: BlendTrans1 | Initial Pass/Fail: Pass | Overall Compliance: No |

**Not Found, R305.1.4, R305.2, R304.5.4**

| Compliance | Description | Data | Compliance | Description | Data |
|---|---|---|---|---|---|
| Yes | Landing X Slope (%) | 0.2 | No | DWS Full Width? | No |
| N/A | Landing Curb? (Y/N) | No | No | DWS Offset (in) | 3.0 |
| Yes | Gutter Ponding? | No | No | Gutter Slope (%) | 5.5 |
| | | | No | Curb Slope (%) | 11.2 |

**Remove & Replace Curb Ramp With Two New Directional Ramps or Equivalent. Remove & Replace Gutter.**
