Access Compliance Report

Public Rights-of-Way (Curb Ramps)

Intersection ID: N/A		Main Street: ASCENSION_WY		Cross Street: INNOVATION_DR		Location: E											
ADA ID: 828FF325BB9E		Ramp Type: Directional1		Initial Pass/Fail: Fail		Overall Compliance: No		Severity Score: 12.5									
Codes/Mitigation Info/Possible Solution				Field Measurements/Component Compliance													
<div>

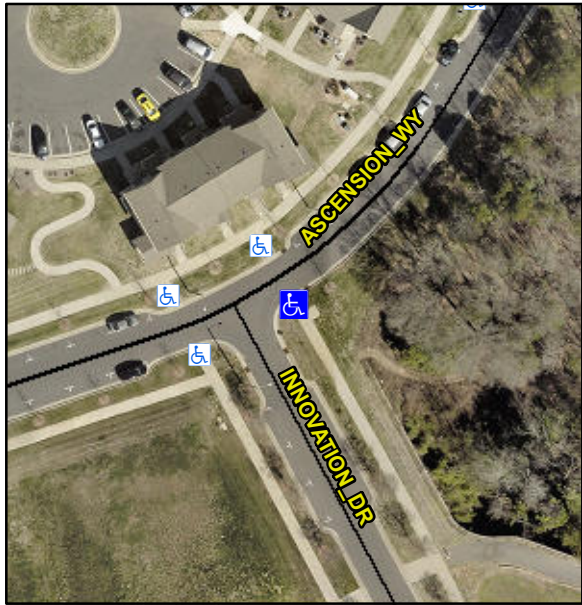
Yes		Ramp Slope (%)		7.4		N/A		Grade Break XSlope (%)		0.0		0.0	
				No		Ramp XSlope (%)		5.8									
				N/A		Flare Type LT		N/A		N/A		Flare Type RT		N/A		N/A	
				N/A		Flare Slope LT (%)		N/A		N/A		Flare Slope RT (%)		0.0		0.0	
				N/A		Flare Traversable LT?		N/A		N/A		Flare Traversable RT?		N/A		N/A	
				N/A		Landing Length (in)		0.0		N/A		DWS Provided?		N/A		N/A	
				N/A		Landing Width (in)		0.0		N/A		DWS Contrast?		N/A		N/A	
				N/A		Landing Slope (%)		0.0		N/A		DWS Length (in)		N/A		N/A	
				N/A		Landing X Slope (%)		0.0		N/A		DWS Full Width?		N/A		N/A	
				N/A		Landing Curb? (Y/N)		N/A		N/A		DWS Offset LT (in)		N/A		N/A	
				N/A		Shared Landing?		N/A		N/A		DWS Offset RT (in)		N/A		N/A	
				N/A		Gutter Ponding?		0.0		N/A		Gutter Slope (%)		N/A		N/A	
				N/A		Gutter Lip Ht (in)		0.0		N/A		Gutter X Slope (%)		N/A		N/A	
				N/A		Painted X Walk1?		No				Road Slope (%)		2.6		2.6	
						X Walk 1 Direction		To NW				Road X Slope (%)		3.3		3.3

</div> <div>Possible Solutions:</div> <div>Remove & Replace Entire Ramp.</div> <div>Surveyor Notes:</div> <div>N/A</div> <div>PROW/ADA:</div> <div>R304.5.3</div> <div>Street 1 Name</div> <div>ASCENSION WY</div> <div>Stop Condition-Street 1</div> <div>None</div> <div>Street 2 Name</div> <div>N/A</div> <div>Stop Condition-Street 2</div> <div>N/A</div> <div>Total Cost:</div> <div>\$</div> <div>1600.00</div>				Compliance		Description		Data		Compliance		Description		Data			
				N/A		Ramp Length (in)		72.0		N/A		Grade Break?		N/A		N/A	
				Yes		Ramp Width (in)		71.0		N/A		Grade Break Slope (%)		0.0		0.0
