# Access Compliance Report

## Public Rights-of-Way

### (Curb Ramps)

| Intersection ID: 31794 | Main Street: ROMARE_BEARDEN_DR | Cross Street: SPRING_FOREST_DR | Location: SW |

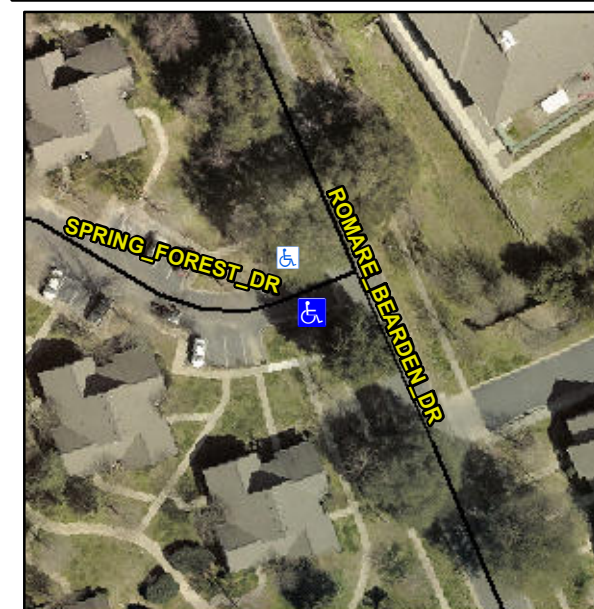
**Not Found, R304.2.2, R304.5.3**

| Compliance | Description | Data | Compliance | Description | Data |
|---|---|---|---|---|---|
| N/A | Ramp Length (in) | 62.0 | No | Ramp Slope (%) | 9.0 |
| Yes | Ramp Width (in) | 48.0 | No | Ramp XSlope (%) | 5.8 |

Possible Solutions:

**Remove & Replace Entire Ramp.**

Total Cost: \$ 1850.00
