Access Compliance Report Public Rights-of-Way (Curb Ramps)

Cross Street: CLAY AV Location: Intersection ID: 10857 Main Street: ALICE AV Ν Initial Pass/Fail: Fail **Overall Compliance: No ADA ID: 8295B2CEC1E2** Ramp Type: Combination1 Severity Score: 33.75

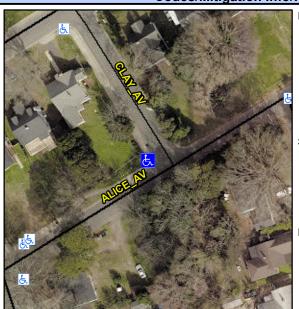
None Street 1 Name Stop Condition-Street 1 **CLAY AV** N/A Street 2 Name Stop Condition-Street 2 N/A Possible Solutions: Compliance Description N/A Remove & Replace Entire Ramp. No Yes No N/A No Surveyor Notes: N/A LT RP < 5% N/A N/A N/A N/A PROW/ADA: N/A R304.5.1, R304.5.1, R304.2.2, N/A R304.5.3, R304.3.2 N/A N/A N/A N/A N/A
