Access Compliance Report Public Rights-of-Way (Curb Ramps)

Intersection ID: 29461	on ID: 29461 Main Street: N_MYERS_ST			Cross Street: GARDEN_DISTRICT_DR				Location:	W
ADA ID: 82A3F9B39D75	2A3F9B39D75 Ramp Type: PerpDiag			Initial Pass/Fail: Fail Overall Compliance: No				o Severity Score:	22.5
Codes/Mitigation Info/Possible Solution				Field Measurements/Component Compliance					
	May 1	Possible Solutions:		Compliance Description Data			Compliance Description Data		
A Market Market		Remove & Replace Curb Ra	mp With	N/A	Ramp Length (in)	71.0	No	Ramp Slope (%)	8.6
a feat as		Two New Directional Ramps		No	Ramp Width (in)	37.0	No	Ramp XSlope (%)	3.0
and the second		Equivalent.		N/A	Flare Type LT	N/A	N/A	Flare Type RT	N/A
Contraction of the second seco				N/A	Flare Slope LT (%)	N/A	N/A	Flare Slope RT (%)	N/A
A STON				N/A	Flare Traversable LT?	N/A	N/A	Flare Traversable RT?	N/A
	Real Property of the second second			N/A	Landing Length (in)	N/A	N/A	DWS Provided?	N/A

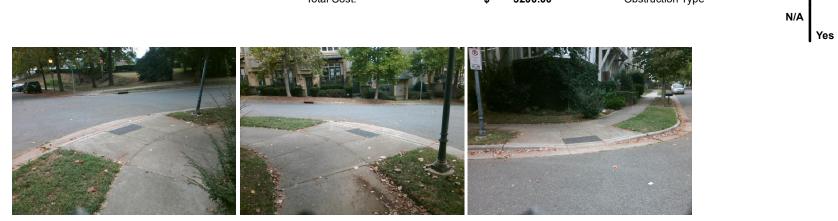
361	Const.	Surveyor Notes:		N/A	Landing Width (in)	N/A	N/A	DWS Contrast?	N/A
N/A PROW/ADA: Not Found, R304.5.1, R304.2.2, R304.5.3				N/A	Landing Slope (%)	N/A	N/A	DWS Length (in)	N/A
				N/A	Landing X Slope (%)	N/A	N/A	DWS Full Width?	N/A
				N/A	Landing Curb? (Y/N)	N/A	N/A	DWS Offset (in)	N/A
				N/A	Shared Landing?	N/A			
				N/A	Gutter Ponding?	N/A	N/A	Gutter Slope (%)	N/A

2.2.	N/A	Gutter Lip Ht (in)	N/A	N/A	Gutter X Slope (%)	N/A
			,	N/A	Painted X Walk1?	No	N/A	Painted X Walk2?	No
					X Walk 1 Direction	To SE		X Walk 2 Direction	To NE
				N/A	X Walk 1 Width (in)	N/A	N/A	X Walk 2 Width (in)	N/A
Street 1 Name	N MYERS ST				X Walk 1 Slope (%)	6.2		X Walk 2 Slope (%)	4.0
Stop Condition-Street 2	StopSign				X Walk 1 X Slope (%)	1.9		X Walk 2 X Slope (%)	6.0
Street 2 Name	GARDEN DISTRICT DR			N/A	Ramp inside XWalk1?	N/A	N/A	Ramp inside XWalk2?	N/A
Stop Condition-Street 1	None				Road Slope (%)	4.1	N/A	Clear Space?	N/A
					Road X Slope (%)	8.5	N/A	Clear Space to XWalk (in)	N/A
				N/A	Any Obstructions?	N/A	N/A	Storm Grate/Utility Hazard?	N/A
		Total Cost:	3200.00		Obstruction Type			Storm Grate/Utility Type	
						N/A			N/A

s Surface Condition? (G/P) Good
