Access Compliance Report

Public Rights-of-Way

(Curb Ramps)

Intersection ID: 44480	Main Street: LOYALIST_ST	Cross Street: REDDING_GLEN_AV	Location: SE
ADA ID: 82A4385E72B9	Ramp Type: Perp	Initial Pass/Fail: Fail	Overall Compliance: No
Severity Score: 8.75			
Codes/Mitigation Info/Possible Solution		Field Measurements/Component Compliance

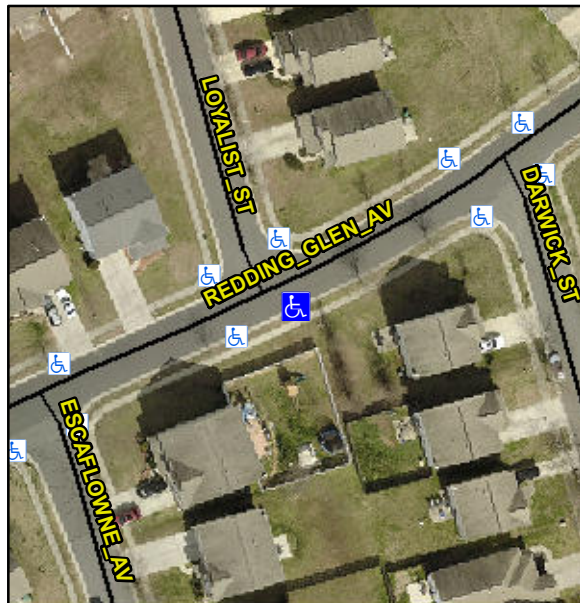
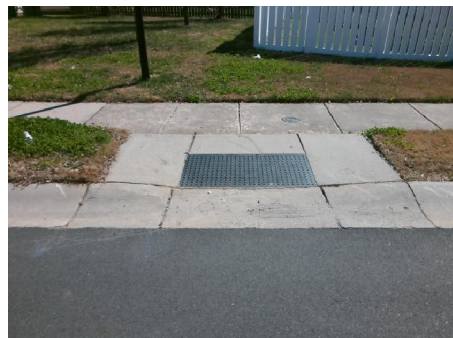
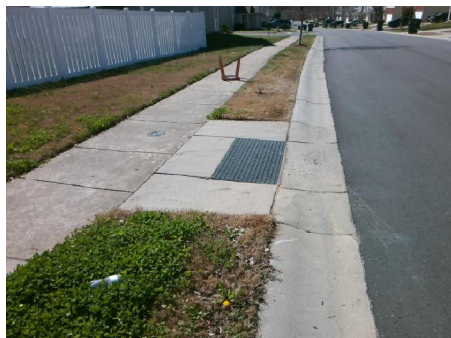
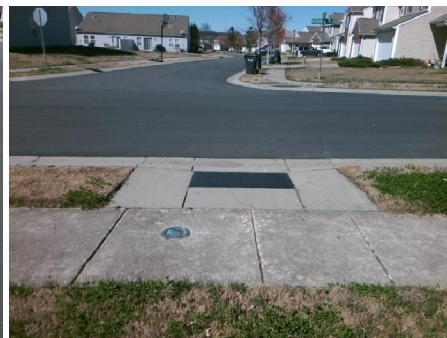
Not Found, R304.5.1

Compliance	Description	Data	Compliance	Description	Data
N/A	Ramp Length (in)	48.0	Yes	Ramp Slope (%)	6.5
No	Ramp Width (in)	47.0	Yes	Ramp XSlope (%)	0.9
N/A	Flare Type LT	N/A	N/A	Flare Type RT	N/A
N/A	Flare Slope LT (%)	N/A	N/A	Flare Slope RT (%)	N/A
N/A	Flare Traversable LT?	N/A	N/A	Flare Traversable RT?	N/A
N/A	Landing Length (in)	N/A	N/A	DWS Provided?	N/A
N/A	Landing Width (in)	N/A	N/A	DWS Contrast?	N/A
N/A	Landing Slope (%)	N/A	N/A	DWS Length (in)	N/A
N/A	Landing X Slope (%)	N/A	N/A	DWS Full Width?	N/A
N/A	Landing Curb? (Y/N)	N/A	N/A	DWS Offset (in)	N/A
N/A	Shared Landing?	N/A			
N/A	Gutter Ponding?	N/A	N/A	Gutter Slope (%)	N/A
N/A	Gutter Lip Ht (in)	N/A	N/A	Gutter X Slope (%)	N/A
N/A	Painted X Walk1?	No	N/A	Painted X Walk2?	N/A
	X Walk 1 Direction	To N		X Walk 2 Direction	N/A
N/A	X Walk 1 Width (in)	N/A	N/A	X Walk 2 Width (in)	N/A
	X Walk 1 Slope (%)	2.0		X Walk 2 Slope (%)	N/A
	X Walk 1 X Slope (%)	1.7		X Walk 2 X Slope (%)	N/A

N/A	Ramp inside XWalk1?	N/A	N/A	Ramp inside XWalk2?	N/A
	Road Slope (%)	N/A	N/A	Clear Space?	N/A
	Road X Slope (%)	N/A	N/A	Clear Space to XWalk (in)	N/A
N/A	Any Obstructions?	N/A	N/A	Storm Grate/Utility Hazard?	N/A
	Obstruction Type			Storm Grate/Utility Type	
		N/A			N/A
			Yes	Surface Condition? (G/P)	Good

Remove & Replace Entire Ramp.
