# Access Compliance Report

## Public Rights-of-Way

### (Curb Ramps)

| Intersection ID: 16139 | Main Street: BILTMORE_DR | Cross Street: CHEROKEE_RD | Location: SW |

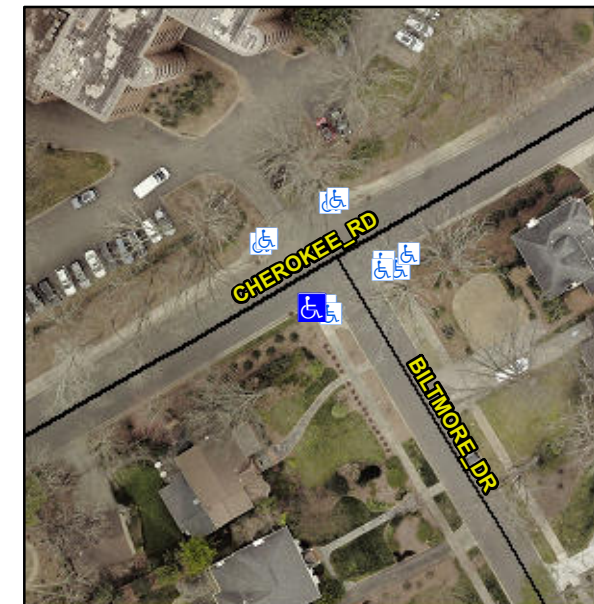
**Not Found, R304.2.2-Perp, R304.3.2-Para, R304.5.4**

| Compliance | Description | Data | Compliance | Description | Data |
|---|---|---|---|---|---|
| No | Landing Slope (%) | 4.2 | Yes | DWS Length (in) | 24.0 |
| Yes | Gutter Ponding? | No | No | Gutter Slope (%) | 6.9 |
| | | | No | Curb Slope (%) | 6.7 |

**Remove & Replace Curb Ramp With Two New Directional Ramps or Equivalent. Remove & Replace Gutter.**
