Access Compliance Report

Public Rights-of-Way

(Curb Ramps)

Intersection ID: 12711	Main Street: E_STONEWALL_ST	Cross Street: S_TRYON_ST	Location: E
ADA ID: 82B66E9D3F97	Ramp Type: Perp	Initial Pass/Fail: Fail	Overall Compliance: No
		Severity Score: 12.5

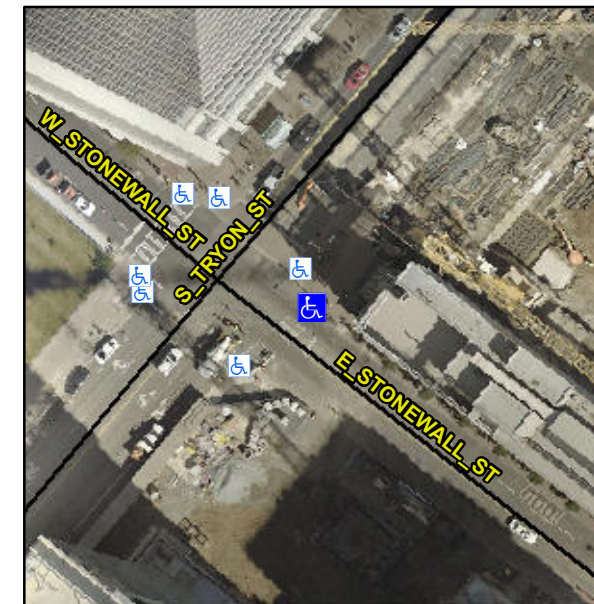
Compliance	Description	Data	Compliance	Description	Data
N/A	Ramp Length (in)	77.0	No	Ramp Slope (%)	8.9
Yes	Ramp Width (in)	60.0	Yes	Ramp XSlope (%)	0.7
N/A	Flare Type LT	N/A	N/A	Flare Type RT	N/A
N/A	Flare Slope LT (%)	N/A	N/A	Flare Slope RT (%)	N/A
N/A	Flare Traversable LT?	N/A	N/A	Flare Traversable RT?	N/A
N/A	Landing Length (in)	N/A	N/A	DWS Provided?	N/A
N/A	Landing Width (in)	N/A	N/A	DWS Contrast?	N/A
N/A	Landing Slope (%)	N/A	N/A	DWS Length (in)	N/A
N/A	Landing X Slope (%)	N/A	N/A	DWS Full Width?	N/A
N/A	Landing Curb? (Y/N)	N/A	N/A	DWS Offset (in)	N/A
N/A	Shared Landing?	N/A			
N/A	Gutter Ponding?	N/A	N/A	Gutter Slope (%)	N/A
N/A	Gutter Lip Ht (in)	N/A	N/A	Gutter X Slope (%)	N/A
N/A	Painted X Walk1?	Yes	N/A	Painted X Walk2?	N/A
	X Walk 1 Direction	To SW		X Walk 2 Direction	N/A
N/A	X Walk 1 Width (in)	110.0	N/A	X Walk 2 Width (in)	N/A
	X Walk 1 Slope (%)	3.3		X Walk 2 Slope (%)	N/A
	X Walk 1 X Slope (%)	4.0		X Walk 2 X Slope (%)	N/A

Remove & Replace Entire Ramp.
