# Access Compliance Report

## Public Rights-of-Way

### (Curb Ramps)

Intersection ID: 51054	Main Street: MULBERRY_CHURCH_RD	Cross Street: N/A	Location: NW
ADA ID: 82BF3E7A373F	Ramp Type: Perp	Initial Pass/Fail: Fail	Overall Compliance: No
		Severity Score: 8.75

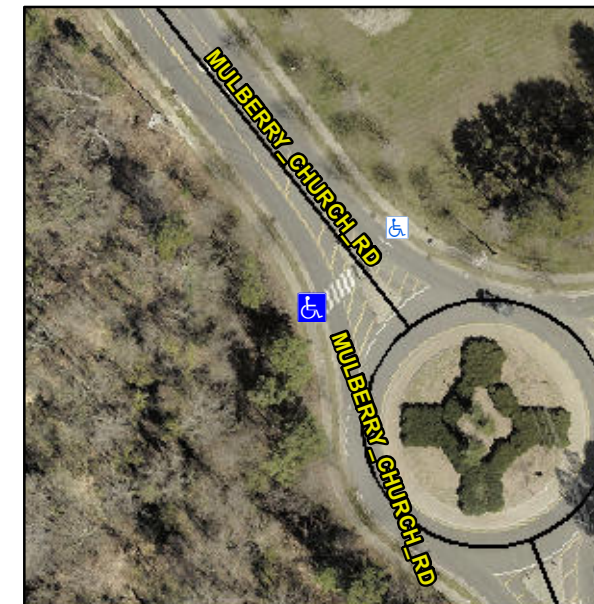
**Not Found, R304.5.1**

Compliance	Description	Data	Compliance	Description	Data
N/A	Ramp Length (in)	48.0	Yes	Ramp Slope (%)	5.1
No	Ramp Width (in)	47.0	Yes	Ramp XSlope (%)	0.7
N/A	Flare Type LT	N/A	N/A	Flare Type RT	N/A
N/A	Flare Slope LT (%)	N/A	N/A	Flare Slope RT (%)	N/A
N/A	Flare Traversable LT?	N/A	N/A	Flare Traversable RT?	N/A
N/A	Landing Length (in)	N/A	N/A	DWS Provided?	N/A
N/A	Landing Width (in)	N/A	N/A	DWS Contrast?	N/A
N/A	Landing Slope (%)	N/A	N/A	DWS Length (in)	N/A
N/A	Landing X Slope (%)	N/A	N/A	DWS Full Width?	N/A
N/A	Landing Curb? (Y/N)	N/A	N/A	DWS Offset (in)	N/A
N/A	Shared Landing?	N/A			
N/A	Gutter Ponding?	N/A	N/A	Gutter Slope (%)	N/A
N/A	Gutter Lip Ht (in)	N/A	N/A	Gutter X Slope (%)	N/A
N/A	Painted X Walk1?	Yes	N/A	Painted X Walk2?	N/A
	X Walk 1 Direction	To E		X Walk 2 Direction	N/A
N/A	X Walk 1 Width (in)	118.0	N/A	X Walk 2 Width (in)	N/A
	X Walk 1 Slope (%)	1.6		X Walk 2 Slope (%)	N/A
	X Walk 1 X Slope (%)	1.0		X Walk 2 X Slope (%)	N/A

N/A	Ramp inside XWalk1?	Yes	N/A	Ramp inside XWalk2?	N/A
	Road Slope (%)	N/A	N/A	Clear Space?	N/A
	Road X Slope (%)	N/A	N/A	Clear Space to XWalk (in)	N/A
N/A	Any Obstructions?	N/A	N/A	Storm Grate/Utility Hazard?	N/A
	Obstruction Type			Storm Grate/Utility Type	
		N/A			N/A
			Yes	Surface Condition? (G/P)	Good

**Remove & Replace Entire Ramp.**

Total Cost: \$ 1850.00
