Access Compliance Report

Public Rights-of-Way

(Curb Ramps)

Intersection ID: 50633	Main Street: BLUE_BLOSSOM_RD	Cross Street: CORAL_ROSE_RD	Location: W
ADA ID: 82CE2C349ACE	Ramp Type: Perp	Initial Pass/Fail: Pass	Overall Compliance: No
Severity Score: 0			
Codes/Mitigation Info/Possible Solution		Field Measurements/Component Compliance

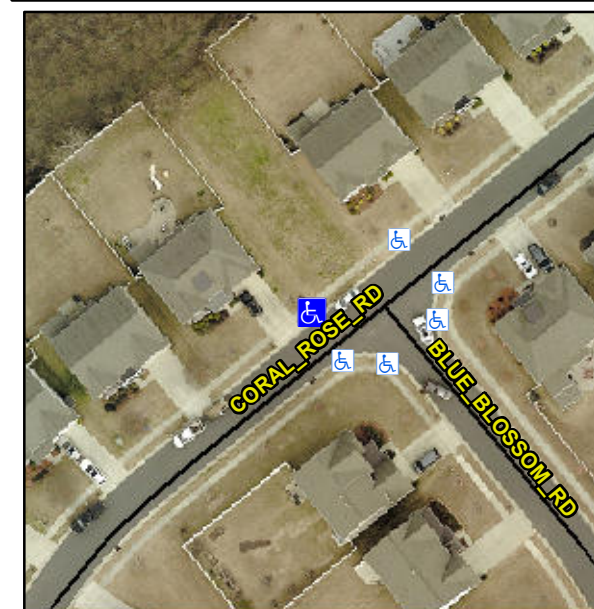
Not Found, R304.2.2-Perp, R304.3.2-Para

Compliance	Description	Data	Compliance	Description	Data
N/A	Ramp Length (in)	47.0	Yes	Ramp Slope (%)	6.0
Yes	Ramp Width (in)	48.0	Yes	Ramp XSlope (%)	1.5
N/A	Flare Type LT	Sloped	N/A	Flare Type RT	N/A
N/A	Flare Slope LT (%)	1.6	Yes	Flare Slope RT (%)	5.8
N/A	Flare Traversable LT?	Yes	N/A	Flare Traversable RT?	Yes
Yes	Landing Length (in)	48.0	Yes	DWS Provided?	Yes
Yes	Landing Width (in)	48.0	Yes	DWS Contrast?	Yes
No	Landing Slope (%)	2.7	Yes	DWS Length (in)	25.5
Yes	Landing X Slope (%)	1.7	Yes	DWS Full Width?	Yes
N/A	Landing Curb? (Y/N)	No	Yes	DWS Offset (in)	0.0
N/A	Shared Landing?	No			
Yes	Gutter Ponding?	No	Yes	Gutter Slope (%)	3.7
Yes	Gutter Lip Ht (in)	0.0	Yes	Gutter X Slope (%)	1.8
N/A	Painted X Walk1?	No	N/A	Painted X Walk2?	N/A
	X Walk 1 Direction	To SE		X Walk 2 Direction	N/A
N/A	X Walk 1 Width (in)	N/A	N/A	X Walk 2 Width (in)	N/A
	X Walk 1 Slope (%)	3.9		X Walk 2 Slope (%)	N/A
	X Walk 1 X Slope (%)	1.4		X Walk 2 X Slope (%)	N/A

N/A	Ramp inside XWalk1?	N/A	N/A	Ramp inside XWalk2?	N/A
	Road Slope (%)	N/A	N/A	Clear Space?	Yes
	Road X Slope (%)	N/A	N/A	Clear Space to XWalk (in)	N/A
Yes	Any Obstructions?	No	Yes	Storm Grate/Utility Hazard?	No
	Obstruction Type			Storm Grate/Utility Type	
		N/A			N/A
			Yes	Surface Condition? (G/P)	Good

Remove & Replace Entire Ramp.
