Access Compliance Report

Public Rights-of-Way

(Curb Ramps)

Intersection ID: 3104	Main Street: DUVALL_MEADOW_LN	Cross Street: LOMAX_RIDGE_DR	Location: S
ADA ID: 82D21ECCE390	Ramp Type: BlendTrans1	Initial Pass/Fail: Pass	Overall Compliance: No
Severity Score: 2.75			
Codes/Mitigation Info/Possible Solution		Field Measurements/Component Compliance

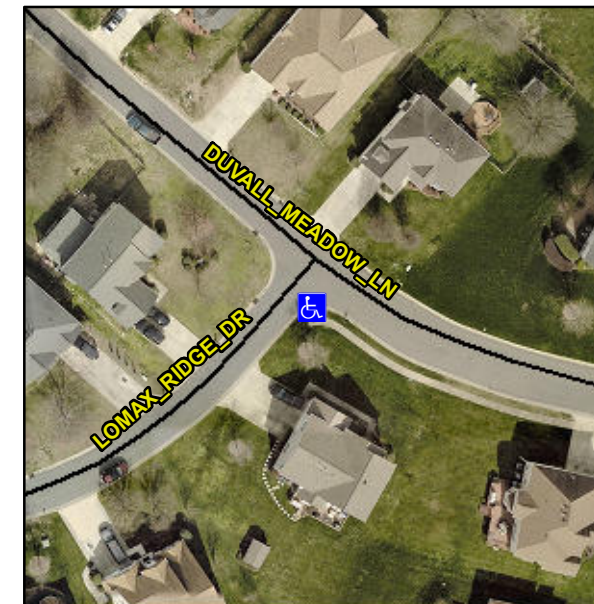
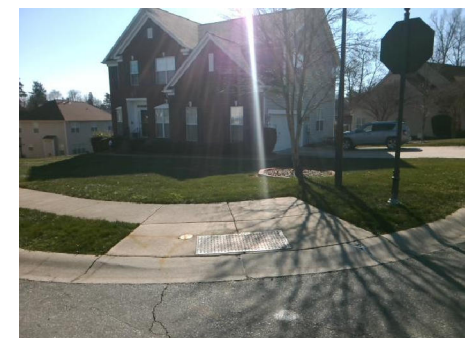
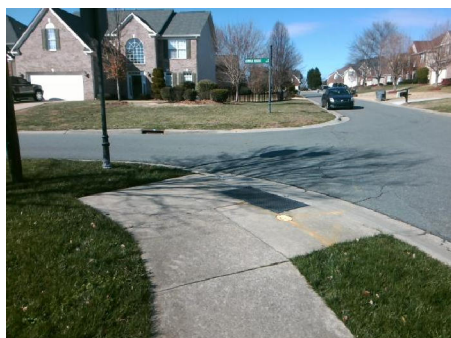
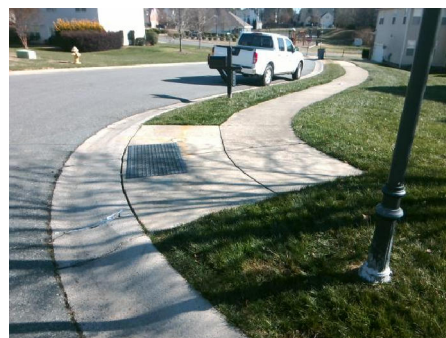
Compliance	Description	Data	Compliance	Description	Data
N/A	Ramp Length (in)	48.5	Yes	BlendTrans Slope (%)	3.4
Yes	Ramp Width (in)	48.0	No	BlendTrans XSlope (%)	3.1
N/A	Flare Type LT	Sloped	N/A	Flare Type RT	Sloped
N/A	Flare Slope LT (%)	0.7	N/A	Flare Slope RT (%)	5.0
N/A	Flare Traversable LT?	No	N/A	Flare Traversable RT?	No
No	Landing Length (in)	47.0	Yes	DWS Provided?	Yes
Yes	Landing Width (in)	52.0	Yes	DWS Contrast?	Yes
No	Landing Slope (%)	2.1	Yes	DWS Length (in)	24.0
No	Landing X Slope (%)	4.4	No	DWS Full Width?	No
N/A	Landing Curb? (Y/N)	No	Yes	DWS Offset (in)	1.0
N/A	Shared Landing?	No			
Yes	Gutter Ponding?	No	Yes	Gutter Slope (%)	3.0
Yes	Gutter Lip Ht (in)	0.0	No	Gutter X Slope (%)	2.1
N/A	Painted X Walk1?	No	N/A	Painted X Walk2?	No
	X Walk 1 Direction	To NE		X Walk 2 Direction	To NW
	X Walk 1 Width (in)	N/A		X Walk 2 Width (in)	N/A
	X Walk 1 Slope (%)	4.2		X Walk 2 Slope (%)	N/A
	X Walk 1 X Slope (%)	3.8		X Walk 2 X Slope (%)	N/A

N/A	Ramp inside XWalk1?	N/A	N/A	Ramp inside XWalk2?	N/A
	Road Slope (%)	3.8		Clear Space?	Yes
	Road X Slope (%)	4.2	N/A	Clear Space to XWalk (in)	N/A
Yes	Any Obstructions?	No	Yes	Storm Grate/Utility Hazard?	No
	Obstruction Type			Storm Grate/Utility Type	
		N/A			N/A
			Yes	Surface Condition? (G/P)	Good
			N/A	Curb Slope (%)	4.7

Possible Solutions:

Remove & Replace Curb Ramp With Two New Directional Ramps or Equivalent. Remove & Replace Gutter.

R304.5.3, R304.2.1, R304.2.2-Perp, R304.3.2-Para, R305.1.4
