# Access Compliance Report

## Public Rights-of-Way

### (Curb Ramps)

| Intersection ID: 10027508 | Main Street: GRANDIFLORA_DR | Cross Street: N/A | Location: NE |

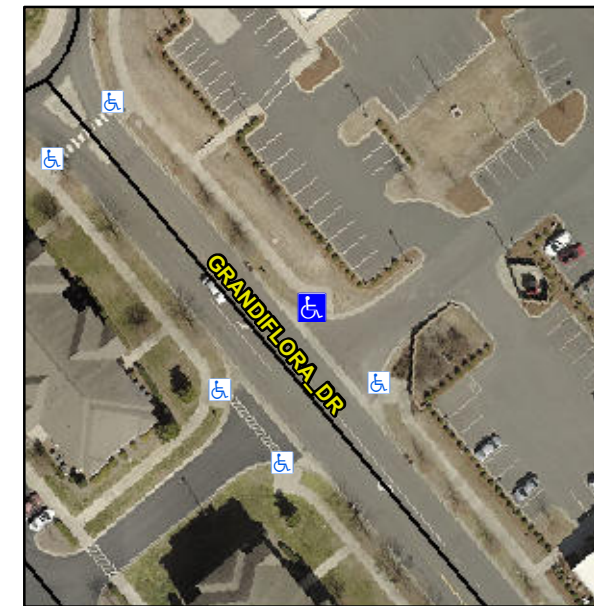
| ADA ID: 82D2536C98C2 | Ramp Type: PerpDiag | Initial Pass/Fail: Fail | Overall Compliance: No |
| Severity Score: 8.75 | | | |

| Compliance | Description | Data | Compliance | Description | Data |
|---|---|---|---|---|---|
| N/A | Ramp Length (in) | 96.5 | Yes | Ramp Slope (%) | 6.1 |
| No | Ramp Width (in) | 45.5 | Yes | Ramp XSlope (%) | 0.8 |

**Remove & Replace Curb Ramp With Two New Directional Ramps or Equivalent.**

**R304.5.1**

Total Cost: \$ 3200.00
