Access Compliance Report

Public Rights-of-Way

(Curb Ramps)

Intersection ID: 42797	Main Street: RED_VULCAN_CT	Cross Street: CRIMSON_SARGENT_DR	Location: S
ADA ID: 82DB3A0029E8	Ramp Type: PerpDiag	Initial Pass/Fail: Fail	Overall Compliance: No
Codes/Mitigation Info/Possible Solution		Field Measurements/Component Compliance	
Severity Score: 33.75

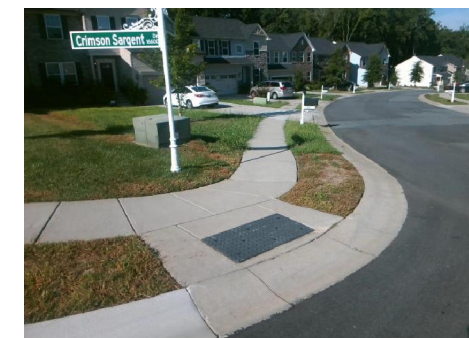
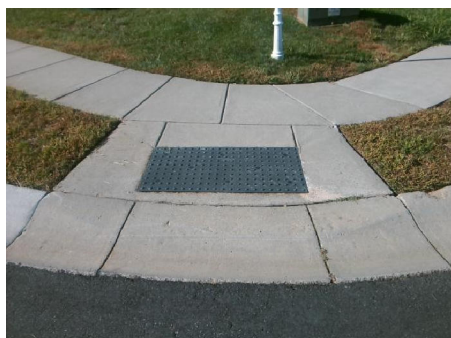
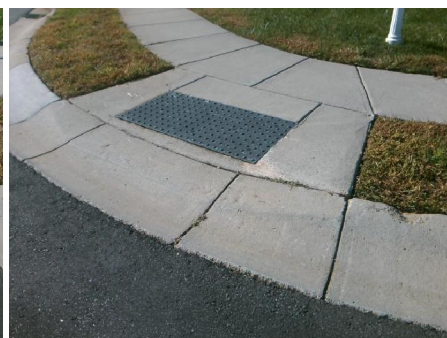
Not Found, R304.5.1, R304.5.3

Compliance	Description	Data	Compliance	Description	Data
N/A	Ramp Length (in)	44.5	Yes	Ramp Slope (%)	5.7
No	Ramp Width (in)	46.5	No	Ramp XSlope (%)	7.0
N/A	Flare Type LT	N/A	N/A	Flare Type RT	N/A
N/A	Flare Slope LT (%)	N/A	N/A	Flare Slope RT (%)	N/A
N/A	Flare Traversable LT?	N/A	N/A	Flare Traversable RT?	N/A
N/A	Landing Length (in)	N/A	N/A	DWS Provided?	N/A
N/A	Landing Width (in)	N/A	N/A	DWS Contrast?	N/A
N/A	Landing Slope (%)	N/A	N/A	DWS Length (in)	N/A
N/A	Landing X Slope (%)	N/A	N/A	DWS Full Width?	N/A
N/A	Landing Curb? (Y/N)	N/A	N/A	DWS Offset (in)	N/A
N/A	Shared Landing?	N/A			
N/A	Gutter Ponding?	N/A	N/A	Gutter Slope (%)	N/A
N/A	Gutter Lip Ht (in)	N/A	N/A	Gutter X Slope (%)	N/A
N/A	Painted X Walk1?	No	N/A	Painted X Walk2?	No
	X Walk 1 Direction	To NE		X Walk 2 Direction	To NW
N/A	X Walk 1 Width (in)	N/A	N/A	X Walk 2 Width (in)	N/A
	X Walk 1 Slope (%)	2.3		X Walk 2 Slope (%)	0.2
	X Walk 1 X Slope (%)	4.8		X Walk 2 X Slope (%)	2.7

N/A	Ramp inside XWalk1?	N/A	N/A	Ramp inside XWalk2?	N/A
	Road Slope (%)	7.2	N/A	Clear Space?	N/A
	Road X Slope (%)	0.4	N/A	Clear Space to XWalk (in)	N/A
N/A	Any Obstructions?	N/A	N/A	Storm Grate/Utility Hazard?	N/A
	Obstruction Type			Storm Grate/Utility Type	
		N/A			N/A
			Yes	Surface Condition? (G/P)	Good

Remove & Replace Curb Ramp With Two New Directional Ramps or Equivalent.
