Access Compliance Report

Public Rights-of-Way

(Curb Ramps)

Intersection ID: 2773	Main Street: EASTFIELD_RD	Cross Street: FOGGY_MEADOW_RD	Location: S
ADA ID: 82E290741994	Ramp Type: Perp	Initial Pass/Fail: Fail	Overall Compliance: No
Severity Score: 12.5			
Codes/Mitigation Info/Possible Solution		Field Measurements/Component Compliance

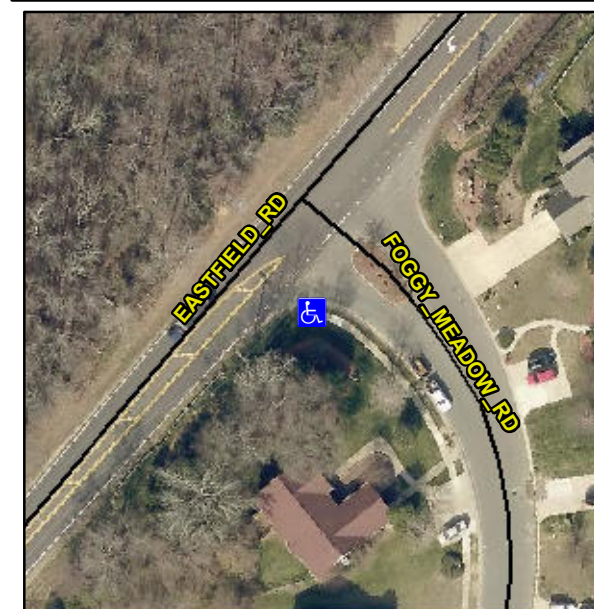
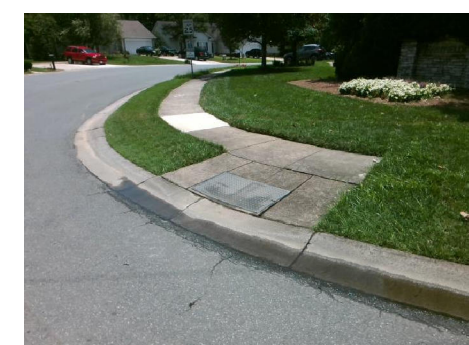
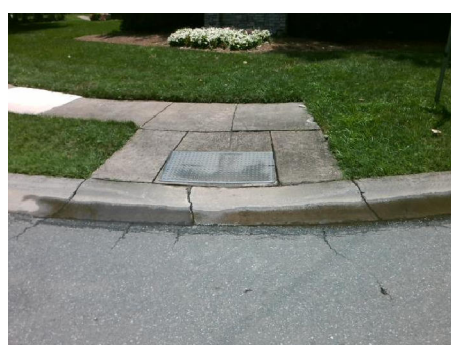
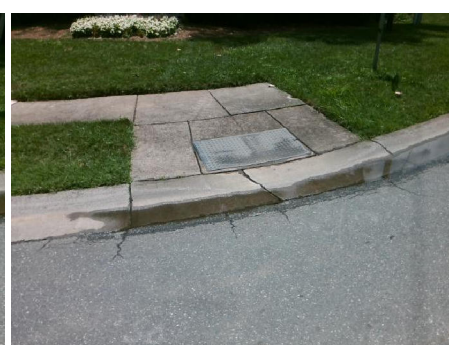
Not Found, R304.2.2

Compliance	Description	Data	Compliance	Description	Data
N/A	Ramp Length (in)	49.0	No	Ramp Slope (%)	10.6
Yes	Ramp Width (in)	52.0	Yes	Ramp XSlope (%)	1.7
N/A	Flare Type LT	N/A	N/A	Flare Type RT	N/A
N/A	Flare Slope LT (%)	N/A	N/A	Flare Slope RT (%)	N/A
N/A	Flare Traversable LT?	N/A	N/A	Flare Traversable RT?	N/A
N/A	Landing Length (in)	N/A	N/A	DWS Provided?	N/A
N/A	Landing Width (in)	N/A	N/A	DWS Contrast?	N/A
N/A	Landing Slope (%)	N/A	N/A	DWS Length (in)	N/A
N/A	Landing X Slope (%)	N/A	N/A	DWS Full Width?	N/A
N/A	Landing Curb? (Y/N)	N/A	N/A	DWS Offset (in)	N/A
N/A	Shared Landing?	N/A			
N/A	Gutter Ponding?	Yes	N/A	Gutter Slope (%)	N/A
N/A	Gutter Lip Ht (in)	N/A	N/A	Gutter X Slope (%)	N/A
N/A	Painted X Walk1?	No	N/A	Painted X Walk2?	N/A
	X Walk 1 Direction	To NE		X Walk 2 Direction	N/A
N/A	X Walk 1 Width (in)	N/A	N/A	X Walk 2 Width (in)	N/A
	X Walk 1 Slope (%)	1.1		X Walk 2 Slope (%)	N/A
	X Walk 1 X Slope (%)	1.4		X Walk 2 X Slope (%)	N/A

N/A	Ramp inside XWalk1?	N/A	N/A	Ramp inside XWalk2?	N/A
	Road Slope (%)	N/A	N/A	Clear Space?	N/A
	Road X Slope (%)	N/A	N/A	Clear Space to XWalk (in)	N/A
N/A	Any Obstructions?	N/A	N/A	Storm Grate/Utility Hazard?	N/A
	Obstruction Type			Storm Grate/Utility Type	
		N/A			N/A
			Yes	Surface Condition? (G/P)	Good

Possible Solutions:

Remove & Replace Entire Ramp.
