Access Compliance Report

Public Rights-of-Way

(Curb Ramps)

Intersection ID: 10795	Main Street: CLEMSON_AV	Cross Street: MATHESON_AV	Location: NE
ADA ID: 82F5944E1582	Ramp Type: Perp	Initial Pass/Fail: Fail	Overall Compliance: No
		Severity Score: 10

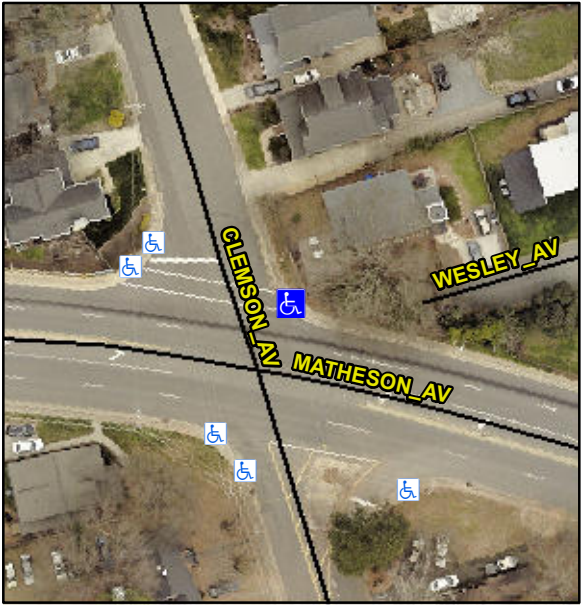
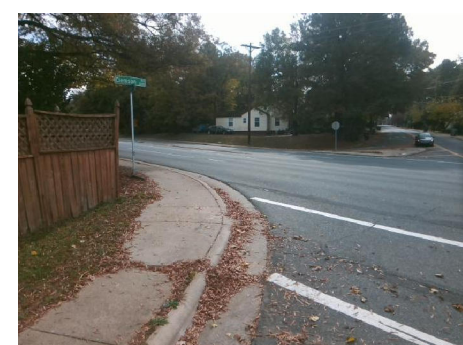
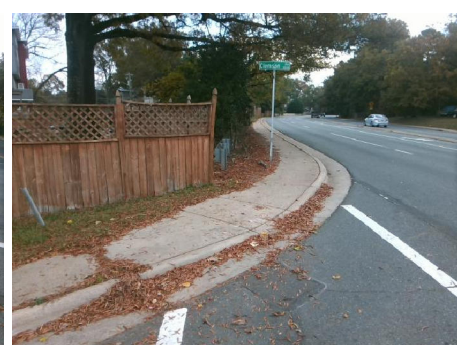
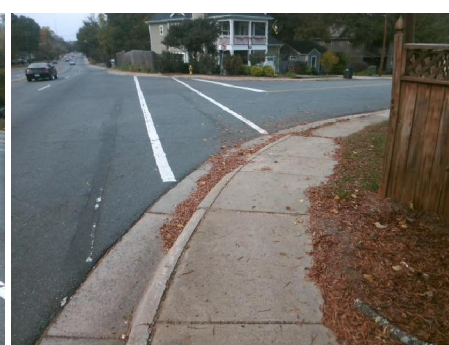
Possible Solutions:		Compliance	Description	Data
	Remove & Replace Entire Ramp.		N/A	Ramp Length (in)	27.0
			No	Ramp Width (in)	44.0
			N/A	Flare Type LT	N/A
			N/A	Flare Slope LT (%)	N/A
			N/A	Flare Traversable LT?	N/A
			N/A	Landing Length (in)	N/A
			N/A	Landing Width (in)	N/A
			N/A	Landing Slope (%)	N/A
			N/A	Landing X Slope (%)	N/A
<p>Surveyor Notes:</p> <p>N/A</p> <p>PROW/ADA:</p> <p>Not Found, R304.5.1, R304.5.3</p>			N/A	Flare Type RT	N/A
			N/A	Flare Slope RT (%)	N/A
			N/A	Flare Traversable RT?	N/A
			N/A	DWS Provided?	N/A
			N/A	DWS Contrast?	N/A
			N/A	DWS Length (in)	N/A
			N/A	DWS Full Width?	N/A
			N/A	DWS Offset (in)	N/A
			N/A	Shared Landing?	N/A
			N/A	Gutter Ponding?	N/A
			N/A	Gutter Lip Ht (in)	N/A
			N/A	Painted X Walk1?	Yes
				X Walk 1 Direction	To NW
			N/A	X Walk 1 Width (in)	102.0
				X Walk 1 Slope (%)	1.3

X Walk 1 X Slope (%)	2.6
			N/A	Ramp inside XWalk1?	Yes
			N/A	Road Slope (%)	N/A
			N/A	Road X Slope (%)	N/A
			N/A	Any Obstructions?	N/A
Total Cost:		\$ 1850.00		Obstruction Type	
			N/A		N/A
			Yes	Surface Condition? (G/P)	Good
