Access Compliance Report Public Rights-of-Way (Curb Ramps)

Intersection ID: 14706 Main Street: FULLIGER_ST Cross Street: HIRAM_ST Location: SE

ADA ID: 82F880BE0942 Ramp Type: Perp Initial Pass/Fail: Pass Overall Compliance: No Severity Score: 15.25

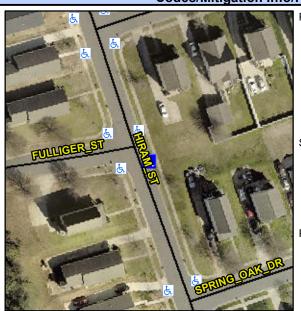
Field Measur	ements/C	ompo	nent Compliance	
Compliance Description		Data	Comp	liance Description	Data
N/A	Ramp Length (in)	48.0	Yes	Ramp Slope (%)	6.2
Yes	Ramp Width (in)	48.0	Yes	Ramp XSlope (%)	4.6
N/A	Flare Type LT	Sloped	N/A	Flare Type RT	N/A
N/A	Flare Slope LT (%)	9.2	N/A	Flare Slope RT (%)	1.0
N/A	Flare Traversable LT?	No	N/A	Flare Traversable RT?	No
No	Landing Length (in)	46.8	No	DWS Provided?	No
Yes	Landing Width (in)	48.0	N/A	DWS Contrast?	No
Yes	Landing Slope (%)	1.2	N/A	DWS Length (in)	N/A
Yes	Landing X Slope (%)	4.8	N/A	DWS Full Width?	No
N/A	Landing Curb? (Y/N)	No	N/A	DWS Offset (in)	N/A
N/A	Shared Landing?	No			
Yes	Gutter Ponding?	No	No	Gutter Slope (%)	6.7
Yes	Gutter Lip Ht (in)	0.0	Yes	Gutter X Slope (%)	4.8
N/A	Painted X Walk1?	No	N/A	Painted X Walk2?	N/A
	X Walk 1 Direction	To W		X Walk 2 Direction	N/A
N/A	X Walk 1 Width (in)	N/A	N/A	X Walk 2 Width (in)	N/A
	X Walk 1 Slope (%)	1.7		X Walk 2 Slope (%)	N/A

X Walk 1 X Slope (%)	5.0		X Walk 2 X Slope (%)	N/A
N/A	Ramp inside XWalk1?	N/A	N/A	Ramp inside XWalk2?	N/A
	Road Slope (%)	N/A	N/A	Clear Space?	Yes
	Road X Slope (%)	N/A	N/A	Clear Space to XWalk (in)	N/A
Yes	Any Obstructions?	No	Yes	Storm Grate/Utility Hazard?	No
	Obstruction Type			Storm Grate/Utility Type	
		N/A			N/A
			Yes	Surface Condition? (G/P)	Good
		'	•	` '

Remove & Replace Entire Ramp.
Remove & Replace Gutter.

R304.2.1, R305, R304.5.4
