Access Compliance Report

Public Rights-of-Way

(Curb Ramps)

Intersection ID: N/A	Main Street: TYVOLA_RD	Cross Street: SPEER_BV	Location: E
ADA ID: 82F9F7FA5E02	Ramp Type: Perp	Initial Pass/Fail: Fail	Overall Compliance: No
		Severity Score: 12.5

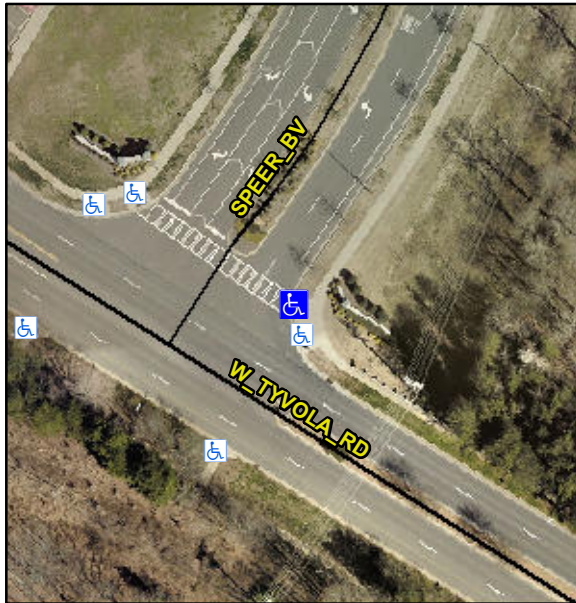
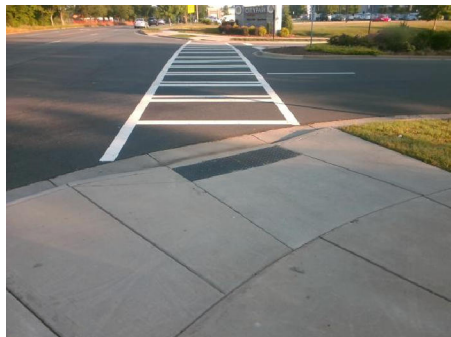
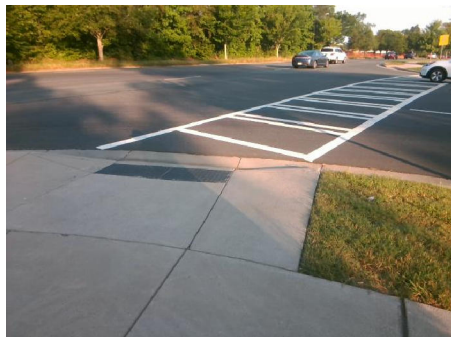
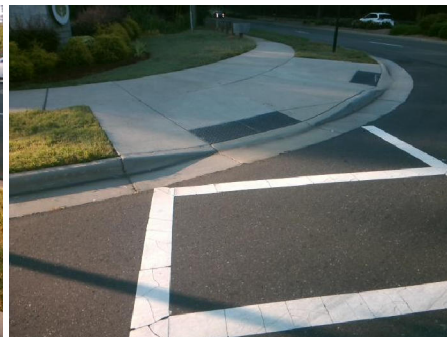
Not Found, R304.5.3

Compliance	Description	Data	Compliance	Description	Data
N/A	Ramp Length (in)	92.5	Yes	Ramp Slope (%)	8.1
Yes	Ramp Width (in)	70.5	No	Ramp XSlope (%)	5.5
N/A	Flare Type LT	N/A	N/A	Flare Type RT	N/A
N/A	Flare Slope LT (%)	N/A	N/A	Flare Slope RT (%)	N/A
N/A	Flare Traversable LT?	N/A	N/A	Flare Traversable RT?	N/A
N/A	Landing Length (in)	N/A	N/A	DWS Provided?	N/A
N/A	Landing Width (in)	N/A	N/A	DWS Contrast?	N/A
N/A	Landing Slope (%)	N/A	N/A	DWS Length (in)	N/A
N/A	Landing X Slope (%)	N/A	N/A	DWS Full Width?	N/A
N/A	Landing Curb? (Y/N)	N/A	N/A	DWS Offset (in)	N/A
N/A	Shared Landing?	N/A			
N/A	Gutter Ponding?	N/A	N/A	Gutter Slope (%)	N/A
N/A	Gutter Lip Ht (in)	N/A	N/A	Gutter X Slope (%)	N/A
N/A	Painted X Walk1?	Yes	N/A	Painted X Walk2?	N/A
	X Walk 1 Direction	To NW		X Walk 2 Direction	N/A
N/A	X Walk 1 Width (in)	113.0	N/A	X Walk 2 Width (in)	N/A
	X Walk 1 Slope (%)	2.7		X Walk 2 Slope (%)	N/A
	X Walk 1 X Slope (%)	4.8		X Walk 2 X Slope (%)	N/A

N/A	Ramp inside XWalk1?	Yes	N/A	Ramp inside XWalk2?	N/A
	Road Slope (%)	N/A	N/A	Clear Space?	N/A
	Road X Slope (%)	N/A	N/A	Clear Space to XWalk (in)	N/A
N/A	Any Obstructions?	N/A	N/A	Storm Grate/Utility Hazard?	N/A
	Obstruction Type			Storm Grate/Utility Type	
		N/A			N/A
			Yes	Surface Condition? (G/P)	Good

Remove & Replace Entire Ramp.
