# Access Compliance Report

## Public Rights-of-Way

### (Curb Ramps)

Intersection ID: 10187	Main Street: ANDERSON_ST	Cross Street: SPENCER_ST	Location: NW
ADA ID: 82FB0A4CFE4E	Ramp Type: Perp	Initial Pass/Fail: Fail	Overall Compliance: No
Severity Score: 46.25			
Codes/Mitigation Info/Possible Solution		Field Measurements/Component Compliance

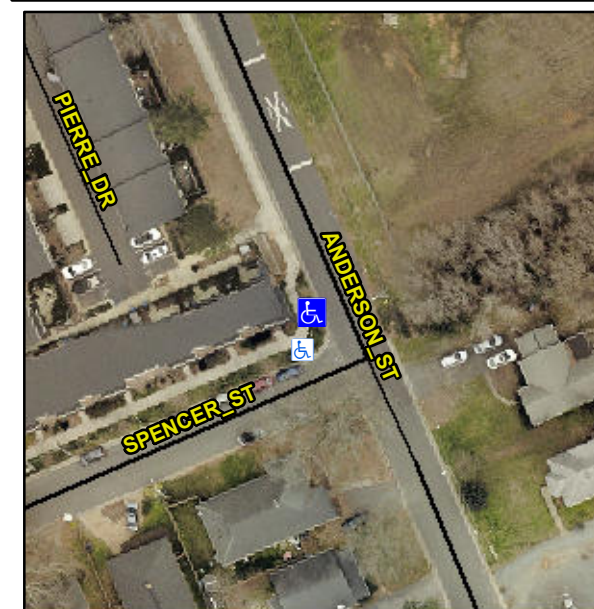
**Not Found, R304.5.1, R304.2.2, R304.5.3**

Compliance	Description	Data	Compliance	Description	Data
N/A	Ramp Length (in)	86.0	No	Ramp Slope (%)	13.7
No	Ramp Width (in)	47.0	No	Ramp XSlope (%)	5.9
N/A	Flare Type LT	N/A	N/A	Flare Type RT	N/A
N/A	Flare Slope LT (%)	N/A	N/A	Flare Slope RT (%)	N/A
N/A	Flare Traversable LT?	N/A	N/A	Flare Traversable RT?	N/A
N/A	Landing Length (in)	N/A	N/A	DWS Provided?	N/A
N/A	Landing Width (in)	N/A	N/A	DWS Contrast?	N/A
N/A	Landing Slope (%)	N/A	N/A	DWS Length (in)	N/A
N/A	Landing X Slope (%)	N/A	N/A	DWS Full Width?	N/A
N/A	Landing Curb? (Y/N)	N/A	N/A	DWS Offset (in)	N/A
N/A	Shared Landing?	N/A			
N/A	Gutter Ponding?	N/A	N/A	Gutter Slope (%)	N/A
N/A	Gutter Lip Ht (in)	N/A	N/A	Gutter X Slope (%)	N/A
N/A	Painted X Walk1?	No	N/A	Painted X Walk2?	N/A
	X Walk 1 Direction	To E		X Walk 2 Direction	N/A
N/A	X Walk 1 Width (in)	N/A	N/A	X Walk 2 Width (in)	N/A
	X Walk 1 Slope (%)	5.7		X Walk 2 Slope (%)	N/A
	X Walk 1 X Slope (%)	5.8		X Walk 2 X Slope (%)	N/A

N/A	Ramp inside XWalk1?	N/A	N/A	Ramp inside XWalk2?	N/A
	Road Slope (%)	5.8	N/A	Clear Space?	N/A
	Road X Slope (%)	5.7	N/A	Clear Space to XWalk (in)	N/A
N/A	Any Obstructions?	N/A	N/A	Storm Grate/Utility Hazard?	N/A
	Obstruction Type			Storm Grate/Utility Type	
		N/A			N/A
			Yes	Surface Condition? (G/P)	Good

**Remove & Replace Entire Ramp.**

Total Cost: \$ 1850.00
