# Access Compliance Report

## Public Rights-of-Way

### (Curb Ramps)

| Intersection ID: 52448 | Main Street: WOODWARD_AV | Cross Street: DOUBLE_OAKS_RD | Location: NW |

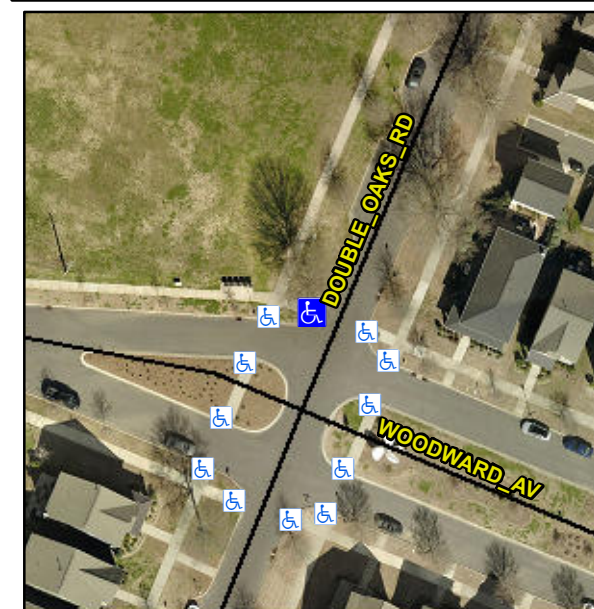
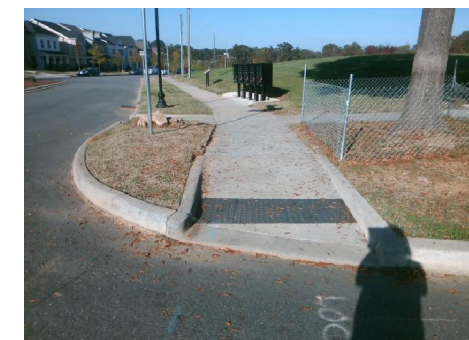
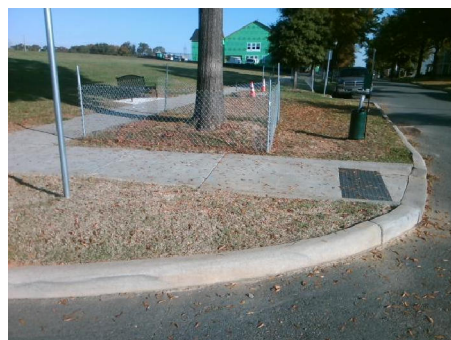
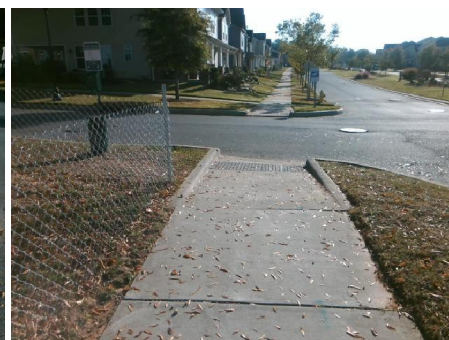
**R304.5.3, R302.7.2**

| Compliance | Description | Data | Compliance | Description | Data |
|---|---|---|---|---|---|
| Yes | Ramp Width (in) | 65.5 | No | Grade Break Slope (%) | 8.1 |
| Yes | Ramp Slope (%) | 4.1 | No | Grade Break XSlope (%) | 3.9 |
| No | Ramp XSlope (%) | 2.6 | | | |
| No | Landing X Slope (%) | 3.3 | Yes | DWS Full Width? | Yes |
| No | Gutter Lip Ht (in) | 1.5 | Yes | Gutter X Slope (%) | 1.2 |

Possible Solutions:

**Remove & Replace Entire Ramp.  
Grind Gutter Lip.**
