Access Compliance Report

Public Rights-of-Way

(Curb Ramps)

Intersection ID: 27772	Main Street: BRIARWICK_LN	Cross Street: NORTH_COMMUNITY_HOUSE_RD	Location: NW
ADA ID: 830B00A296C3	Ramp Type: Perp	Initial Pass/Fail: Fail	Overall Compliance: No
Severity Score: 22.5			
Codes/Mitigation Info/Possible Solution		Field Measurements/Component Compliance

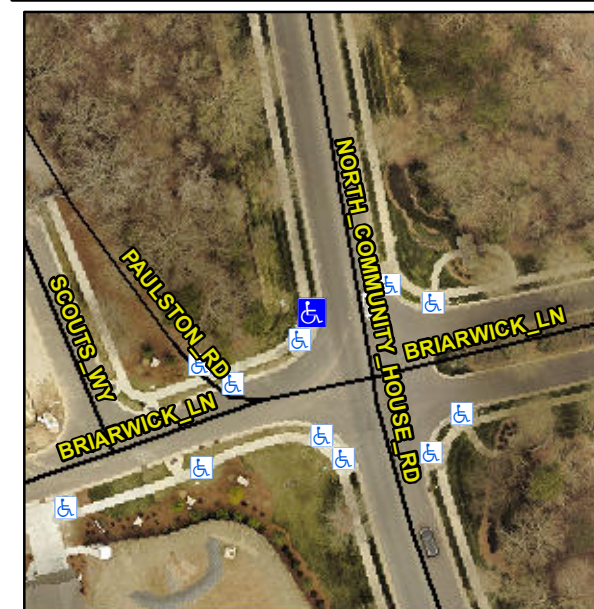
Not Found, R304.5.1, R304.2.2, R304.5.3

Compliance	Description	Data	Compliance	Description	Data
N/A	Ramp Length (in)	103.0	No	Ramp Slope (%)	9.3
No	Ramp Width (in)	40.0	No	Ramp XSlope (%)	4.5
N/A	Flare Type LT	N/A	N/A	Flare Type RT	N/A
N/A	Flare Slope LT (%)	N/A	N/A	Flare Slope RT (%)	N/A
N/A	Flare Traversable LT?	N/A	N/A	Flare Traversable RT?	N/A
N/A	Landing Length (in)	N/A	N/A	DWS Provided?	N/A
N/A	Landing Width (in)	N/A	N/A	DWS Contrast?	N/A
N/A	Landing Slope (%)	N/A	N/A	DWS Length (in)	N/A
N/A	Landing X Slope (%)	N/A	N/A	DWS Full Width?	N/A
N/A	Landing Curb? (Y/N)	N/A	N/A	DWS Offset (in)	N/A
N/A	Shared Landing?	N/A			
N/A	Gutter Ponding?	N/A	N/A	Gutter Slope (%)	N/A
N/A	Gutter Lip Ht (in)	N/A	N/A	Gutter X Slope (%)	N/A
N/A	Painted X Walk1?	No	N/A	Painted X Walk2?	N/A
	X Walk 1 Direction	To NE		X Walk 2 Direction	N/A
N/A	X Walk 1 Width (in)	N/A	N/A	X Walk 2 Width (in)	N/A
	X Walk 1 Slope (%)	5.3		X Walk 2 Slope (%)	N/A
	X Walk 1 X Slope (%)	3.7		X Walk 2 X Slope (%)	N/A

N/A	Ramp inside XWalk1?	N/A	N/A	Ramp inside XWalk2?	N/A
	Road Slope (%)	N/A	N/A	Clear Space?	N/A
	Road X Slope (%)	N/A	N/A	Clear Space to XWalk (in)	N/A
N/A	Any Obstructions?	N/A	N/A	Storm Grate/Utility Hazard?	N/A
	Obstruction Type			Storm Grate/Utility Type	
		N/A			N/A
			Yes	Surface Condition? (G/P)	Good

Remove & Replace Entire Ramp.

Total Cost: \$ 1850.00
