Access Compliance Report Public Rights-of-Way (Curb Ramps)

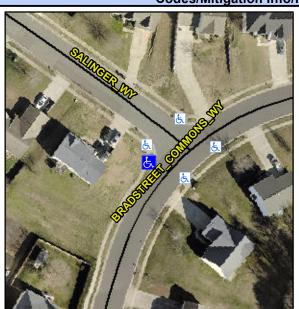
Intersection ID: 29420 Main Street: BRADSTREET_COMMONS_WYCross Street: SALINGER_WY Location: W

BRADSTREET COMMONS WY Street 1 Name Stop Condition-Street 2 None Street 2 Name N/A Stop Condition-Street 1 N/A

Possible Solutions:			
Remove & Replace Entire Ramp.			
•	N		
	N		
	1		
	1		
	1		
Surveyor Notes:	1		
N/A	1		
	1		
	1		
	1		
PROW/ADA:	1		
Not Found, R304.5.1	N		
	N		
	١

4
