# Access Compliance Report

## Public Rights-of-Way

| Intersection ID: 17226 | Main Street: N_CANTERBURY_RD | Cross Street: RANDOLPH_RD | Location: SE |
| ADA ID: 831AD3EBD6D0 | Ramp Type: PerpDiag | Initial Pass/Fail: Fail | Overall Compliance: No |

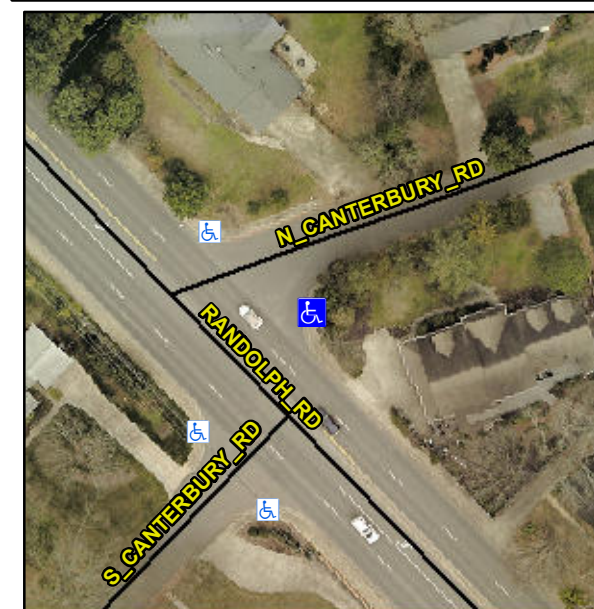
| Severity Score: 37.5 | | | |

**R304.2.2, R304.5.3**

| Compliance | Description | Data | Compliance | Description | Data |
|---|---|---|---|---|---|
| N/A | Ramp Length (in) | 47.0 | No | Ramp Slope (%) | 12.9 |
| Yes | Ramp Width (in) | 48.0 | No | Ramp XSlope (%) | 6.3 |

**Remove & Replace Curb Ramp With Two New Directional Ramps or Equivalent.**

Total Cost: \$ 3200.00
