## Access Compliance Report Public Rights-of-Way (Curb Ramps)

Intersection ID: 42582 Main Street: N\_CHURCH\_ST Cross Street: N\_TRYON\_ST Location: SW

ADA ID: 831C3BDB4A36 Ramp Type: Para Initial Pass/Fail: Fail Overall Compliance: No Severity Score: 12.5

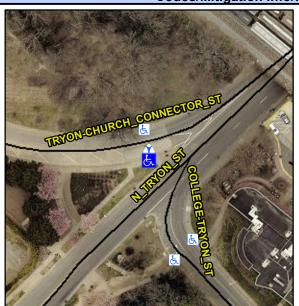
NO LT RAMP

Data	Compliance Description		Compliance Description Data		Comp
237.0	Ramp Length RT (in)	N/A	N/A	Ramp Length LT (in)	N/A
59.0	Ramp Width RT (in)	Yes	N/A	Ramp Width LT (in)	N/A

8.6	Ramp Slope RT (%)	Yes	N/A	Ramp Slope LT (%)	N/A
1.8	Ramp XSlope RT (%)	Yes	N/A	Ramp XSlope LT (%)	N/A
N/A	DWS Provided?	N/A	N/A	Landing Length (in)	N/A
N/A	DWS Contrast?	N/A	N/A	Landing Width (in)	N/A
N/A	DWS Length (in)	N/A	N/A	Landing Slope (%)	N/A
N/A	DWS Full Width?	N/A	N/A	Landing X Slope (%)	N/A
N/A	DWS Offset (in)	N/A	N/A	Landing Curb? (Y/N)	N/A
			N/A	Shared Landing?	N/A
N/A	Gutter Slope (%)	N/A	N/A	Gutter Ponding?	N/A
N/A	Gutter X Slope (%)	N/A	N/A	Gutter Lip Ht (in)	N/A
N/A	Painted X Walk2?	N/A	Yes	Painted X Walk1?	N/A
N/A	X Walk 2 Direction		To NW	X Walk 1 Direction	
N/A	X Walk 2 Width (in)	N/A	96.0	X Walk 1 Width (in)	N/A
N/A	X Walk 2 Slope (%)		6.7	X Walk 1 Slope (%)	
N/A	X Walk 2 X Slope (%)		5.1	X Walk 1 X Slope (%)	
N/A	Ramp inside XWalk2?	N/A	Yes	Ramp inside XWalk1?	N/A
N/A	Clear Space?	N/A	N/A	Road Slope (%)	
N/A	Clear Space to XWalk (in)	N/A	N/A	Road X Slope (%)	
N/A	Storm Grate/Utility Hazard?	N/A	N/A	Any Obstructions?	N/A

Storm Grate/Utility Type			Obstruction Type	
N/A			N/A		
Good	Surface Condition? (G/P)	Yes			
21.0	Curb Slope (%)	N/A

Remove & Replace Entire Ramp.
