Access Compliance Report

Public Rights-of-Way

(Curb Ramps)

Intersection ID: 9228	Main Street: FAIRMONT_ST	Cross Street: RENNER_ST	Location: SW
ADA ID: 831FF50BD325	Ramp Type: PerpDiag	Initial Pass/Fail: Fail	Overall Compliance: No
		Severity Score: 12.5

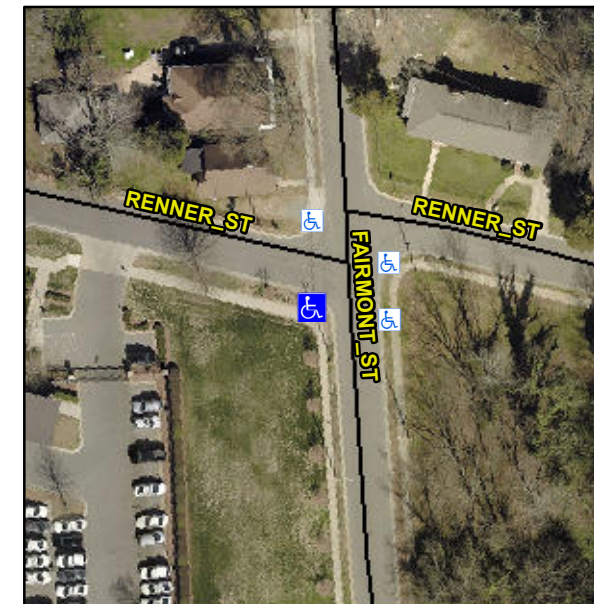
Not Found, R304.2.2

Compliance	Description	Data	Compliance	Description	Data
N/A	Ramp Length (in)	26.0	No	Ramp Slope (%)	11.1
Yes	Ramp Width (in)	48.0	Yes	Ramp XSlope (%)	0.2
N/A	Flare Type LT	N/A	N/A	Flare Type RT	N/A
N/A	Flare Slope LT (%)	N/A	N/A	Flare Slope RT (%)	N/A
N/A	Flare Traversable LT?	N/A	N/A	Flare Traversable RT?	N/A
N/A	Landing Length (in)	N/A	N/A	DWS Provided?	N/A
N/A	Landing Width (in)	N/A	N/A	DWS Contrast?	N/A
N/A	Landing Slope (%)	N/A	N/A	DWS Length (in)	N/A
N/A	Landing X Slope (%)	N/A	N/A	DWS Full Width?	N/A
N/A	Landing Curb? (Y/N)	N/A	N/A	DWS Offset (in)	N/A
N/A	Shared Landing?	N/A			
N/A	Gutter Ponding?	N/A	N/A	Gutter Slope (%)	N/A
N/A	Gutter Lip Ht (in)	N/A	N/A	Gutter X Slope (%)	N/A
N/A	Painted X Walk1?	No	N/A	Painted X Walk2?	No
	X Walk 1 Direction	To E		X Walk 2 Direction	To N
N/A	X Walk 1 Width (in)	N/A	N/A	X Walk 2 Width (in)	N/A
	X Walk 1 Slope (%)	1.8		X Walk 2 Slope (%)	1.6
	X Walk 1 X Slope (%)	2.2		X Walk 2 X Slope (%)	2.3

Remove & Replace Curb Ramp With Two New Directional Ramps or Equivalent.

Total Cost: \$ 3200.00
