Access Compliance Report

Public Rights-of-Way

(Curb Ramps)

Intersection ID: 20968	Main Street: CURRAGHMORE_RD	Cross Street: SHARON_VIEW_RD	Location: SW
ADA ID: 8324CDD2A006	Ramp Type: Para	Initial Pass/Fail: Fail	Overall Compliance: No
			Severity Score: 13.75

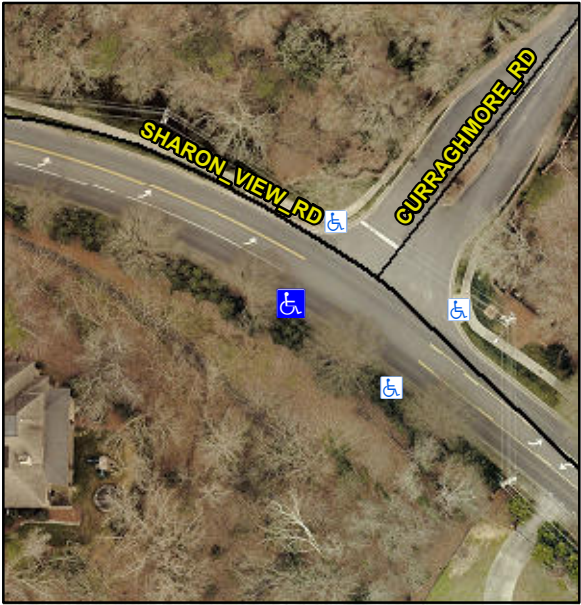
Possible Solutions:		Compliance	Description	Data
	Remove & Replace Entire Ramp.		N/A	Ramp Length LT (in)	69.0
			Yes	Ramp Width LT (in)	55.0
			No	Ramp Slope LT (%)	8.8
			No	Ramp XSlope LT (%)	2.2
			N/A	Landing Length (in)	N/A
			N/A	Landing Width (in)	N/A
			N/A	Landing Slope (%)	N/A
			N/A	Landing X Slope (%)	N/A
			N/A	Landing Curb? (Y/N)	N/A
<p>Surveyor Notes:</p> <p>N/A</p> <p>PROW/ADA:</p> <p>R304.3.2, R304.5.3</p>			N/A	Ramp Length RT (in)	70.0
			Yes	Ramp Width RT (in)	55.0
			Yes	Ramp Slope RT (%)	6.5
			No	Ramp XSlope RT (%)	3.0
			N/A	DWS Provided?	N/A
			N/A	DWS Contrast?	N/A
			N/A	DWS Length (in)	N/A
			N/A	DWS Full Width?	N/A
			N/A	DWS Offset (in)	N/A
			N/A	Gutter Slope (%)	N/A
			N/A	Gutter X Slope (%)	N/A
			N/A	Painted X Walk1?	No
				X Walk 1 Direction	To NE
			N/A	X Walk 1 Width (in)	N/A
				X Walk 1 Slope (%)	3.3

X Walk 1 X Slope (%)	0.5
			N/A	Ramp inside XWalk1?	N/A
			N/A	Road Slope (%)	N/A
			N/A	Road X Slope (%)	N/A
			N/A	Any Obstructions?	N/A
				Obstruction Type	
			N/A		N/A
			Yes	Surface Condition? (G/P)	Good
			N/A	Curb Slope (%)	5.4
Total Cost:		\$ 1600.00
